INDEPENDENT ROOF INSPECTION SERVICES LTD.

INSPECTION REPORT

AUGUST 21 2022
OLYMPUS AVENUE.
TORONTO ONT.

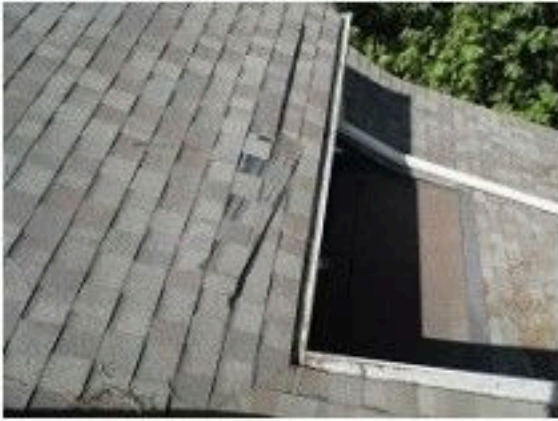
Loose shingle.

- 1) Replace damaged ridge cap shingle.
- 2) Replace loose material.

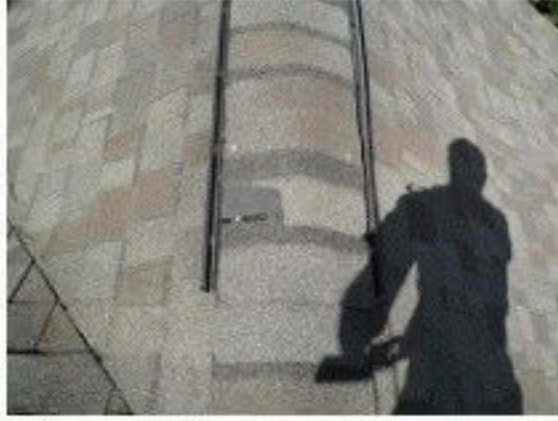
Broken ridge cap shingle.

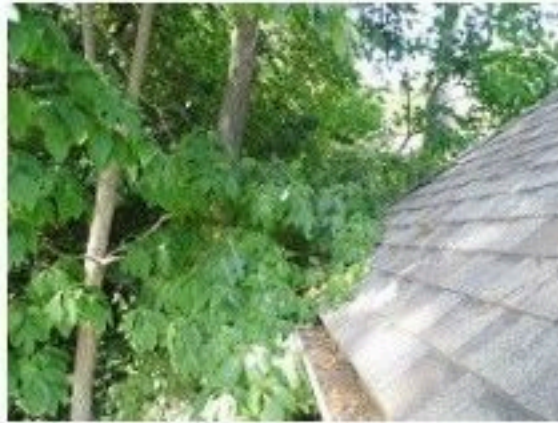
Rear North corner. Branches should be cut back. Trough should be cleaned.

- Clean leaf guard.
- Trim overhanging branches.

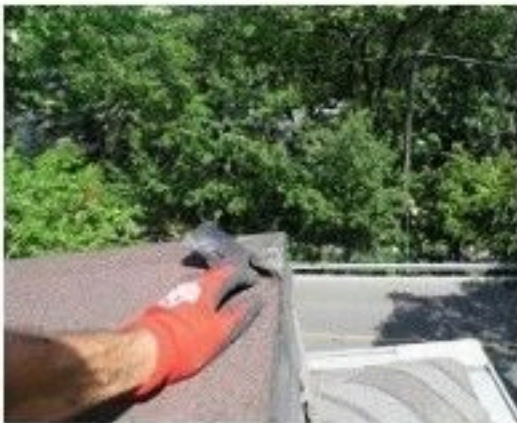
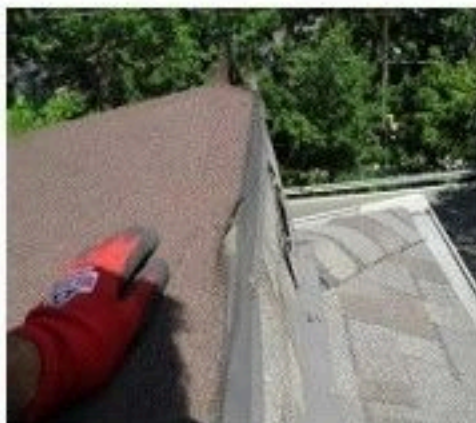
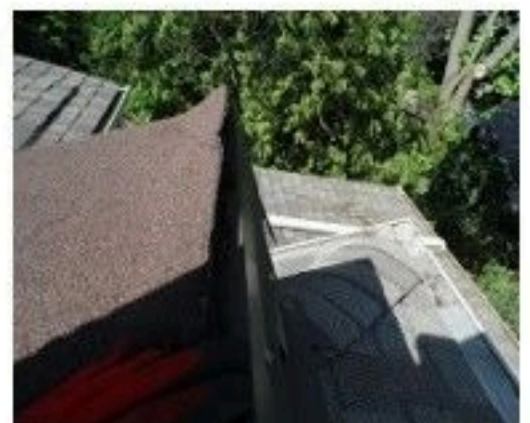
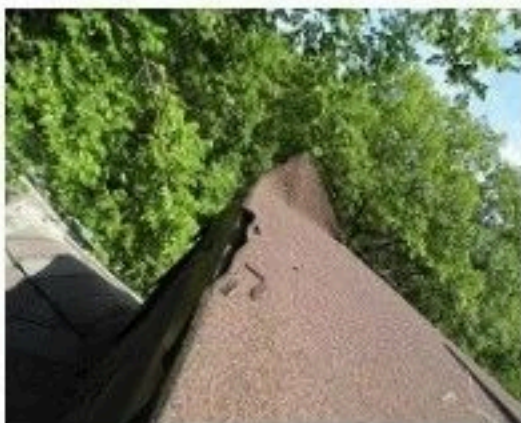
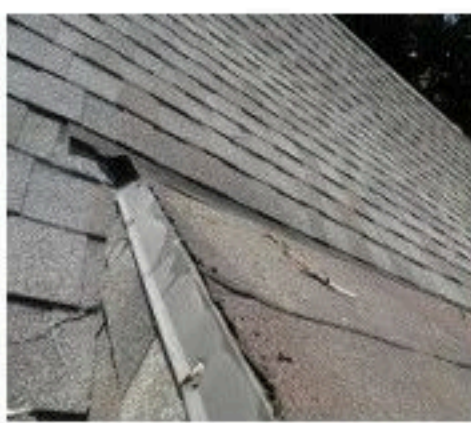
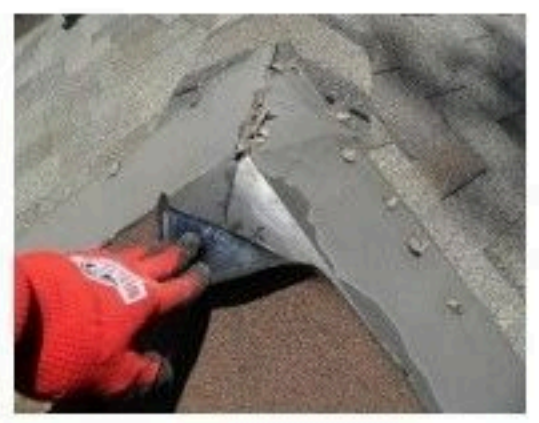
Common to all heat welded flat roof membranes where the sheet metal drip edge was not properly primed. The membrane becomes loose.

All of the roof s and their perimeters show this deficiency.

- 1) Install asphalt primer to all sheet metal drip edge as needed.
- 2) Re-heat existing membrane and fully adhere.
