INDEPENDENT ROOF INSPECTION SERVICES LTD.

INSPECTION REPORT

ETOBICOKE ONTARIO

NOVEMBER 30 2022

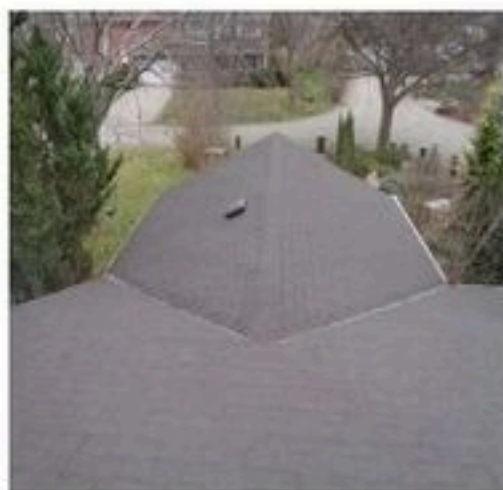
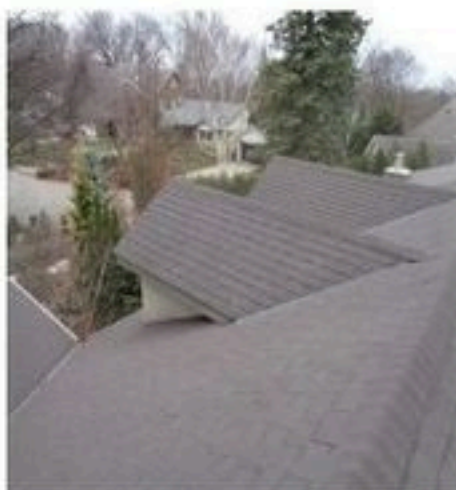
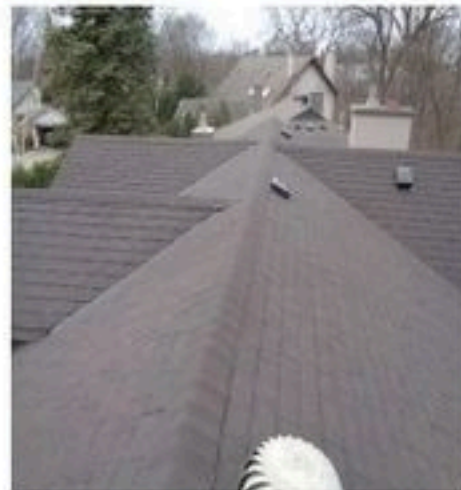
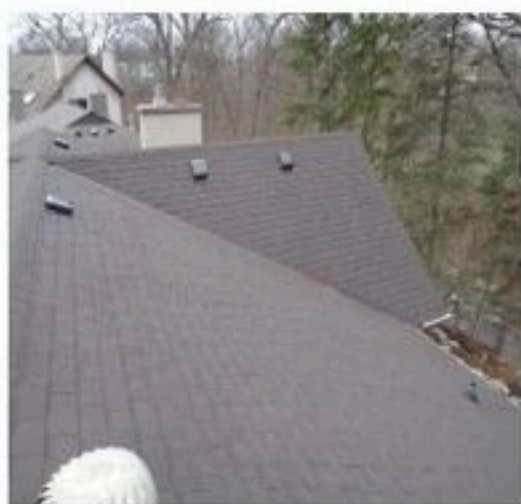
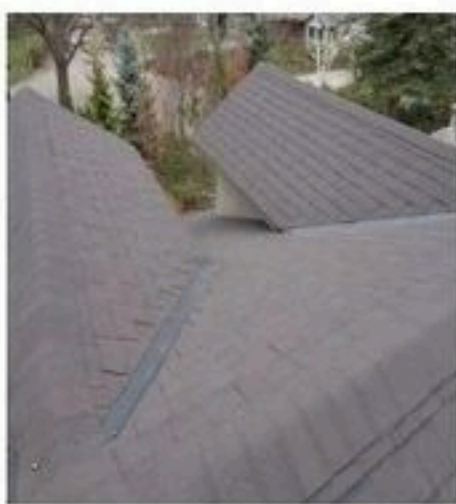
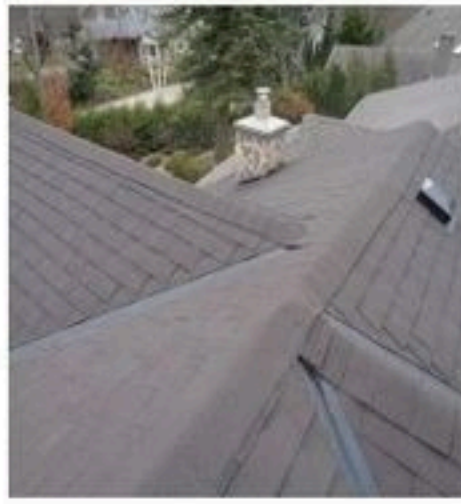
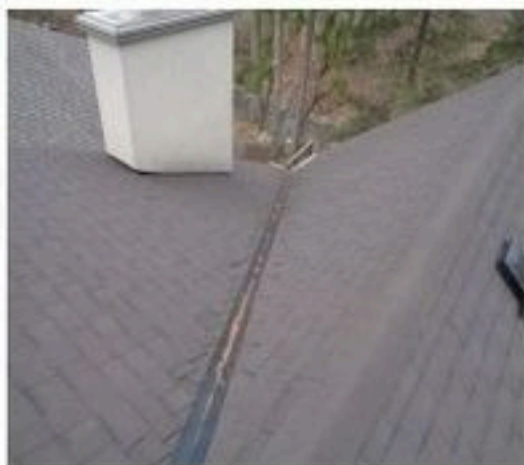
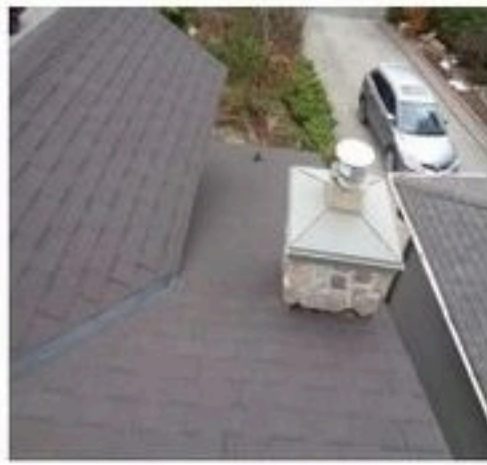
OVERVIEWS.

We find that the installation is entirely deficient, not in accordance with requirements and demonstrates a lack of basic installation practices.

THIS INSTALLATION SHOULD BE COMPLETELY STRIPPED AND REPLACED.

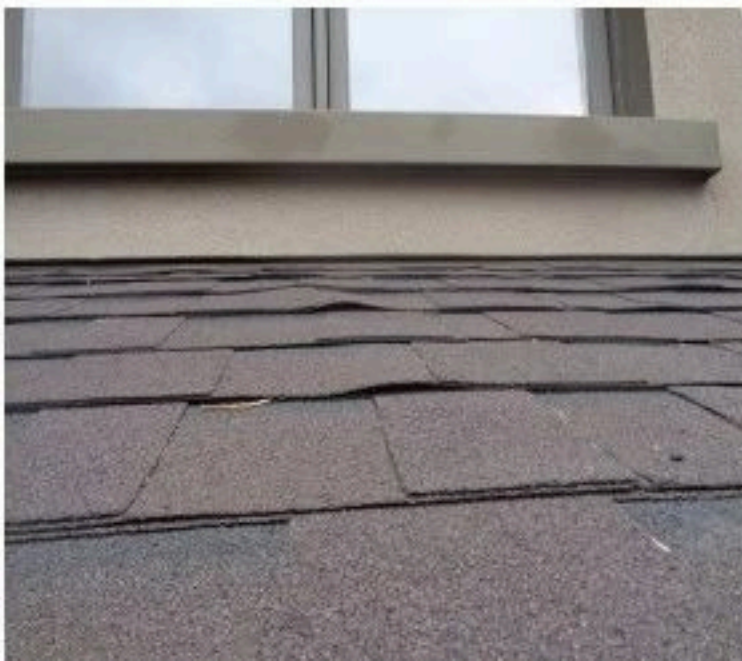
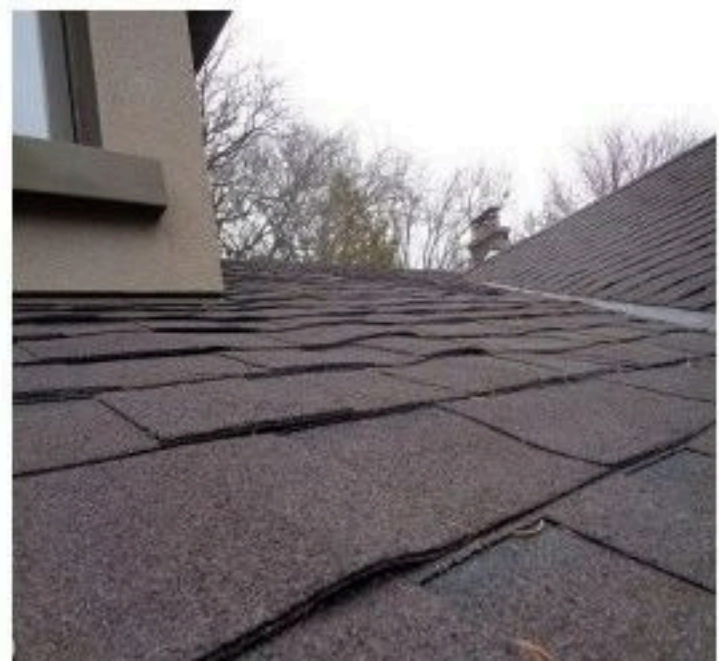
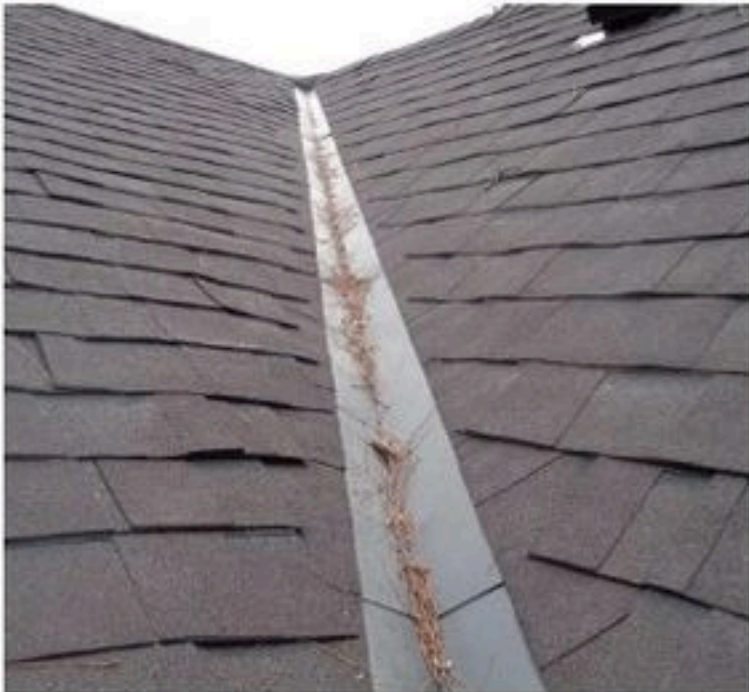
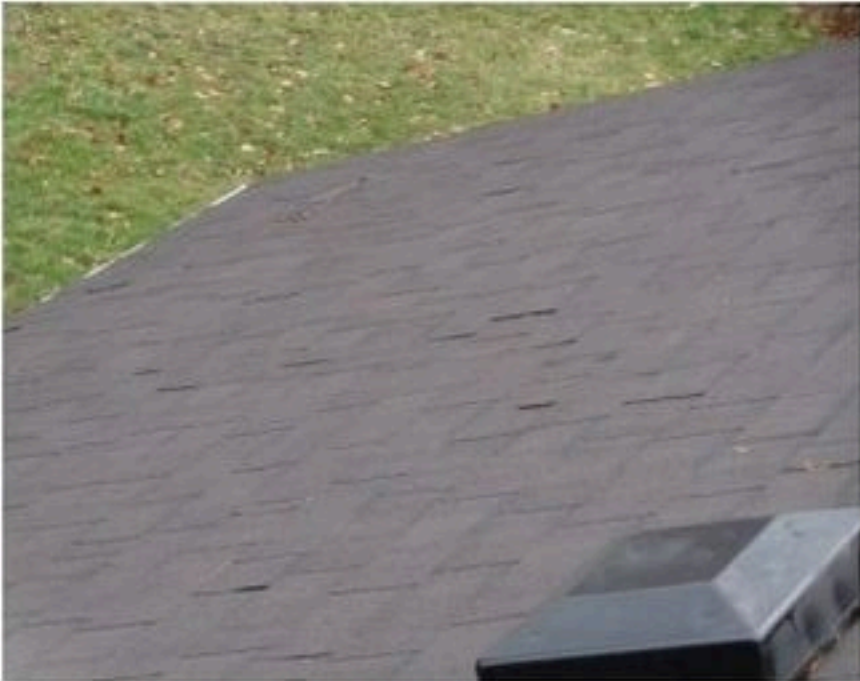
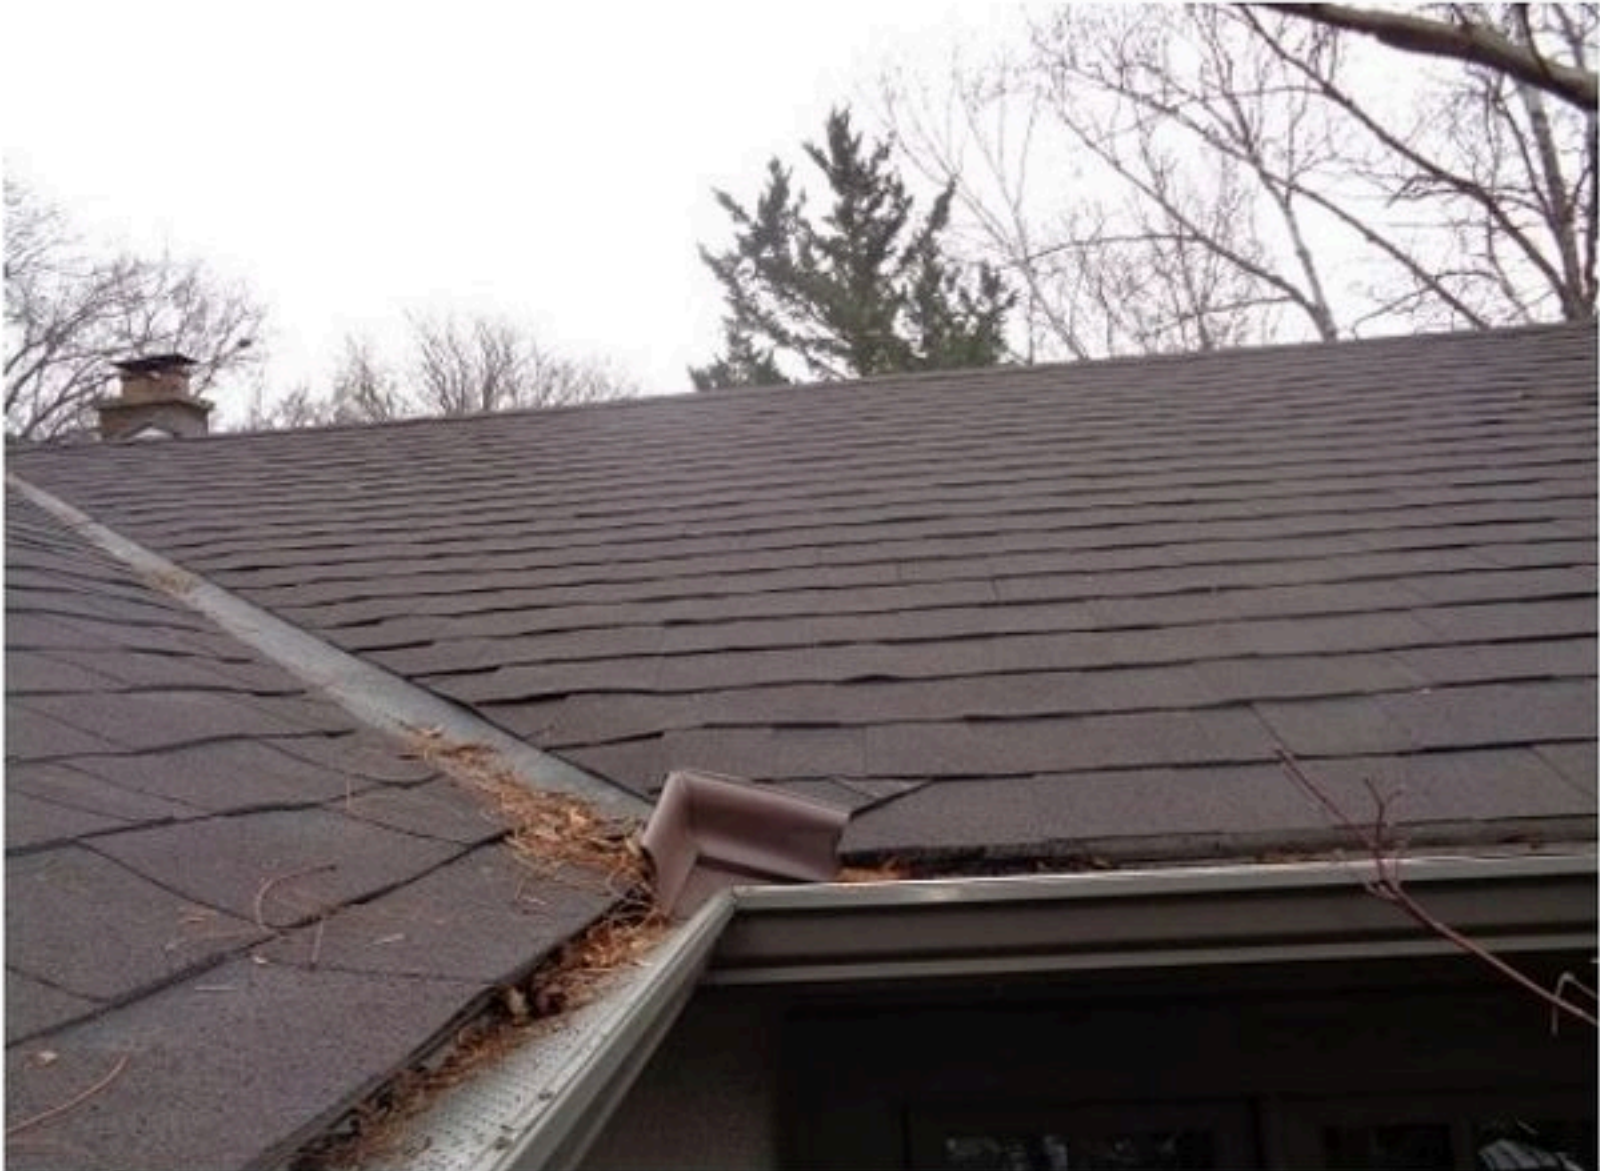
1) The overall appearance is poor and largely due to an overlap at the 'butt' ends.

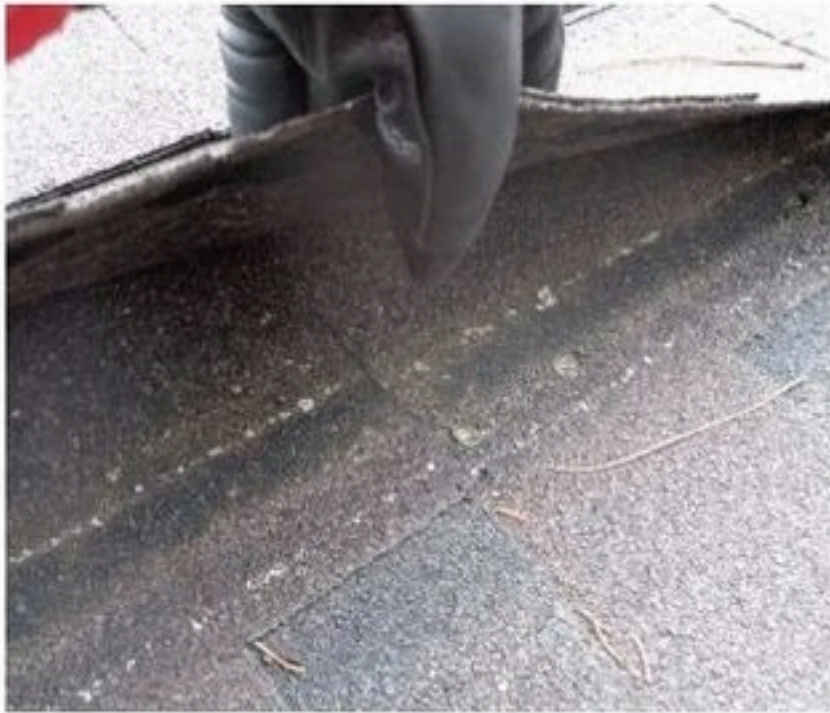
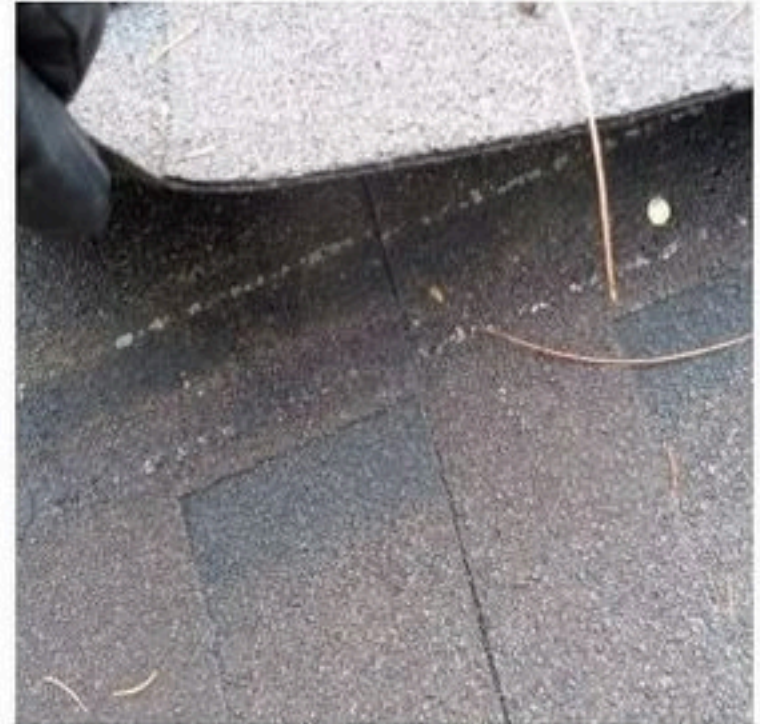
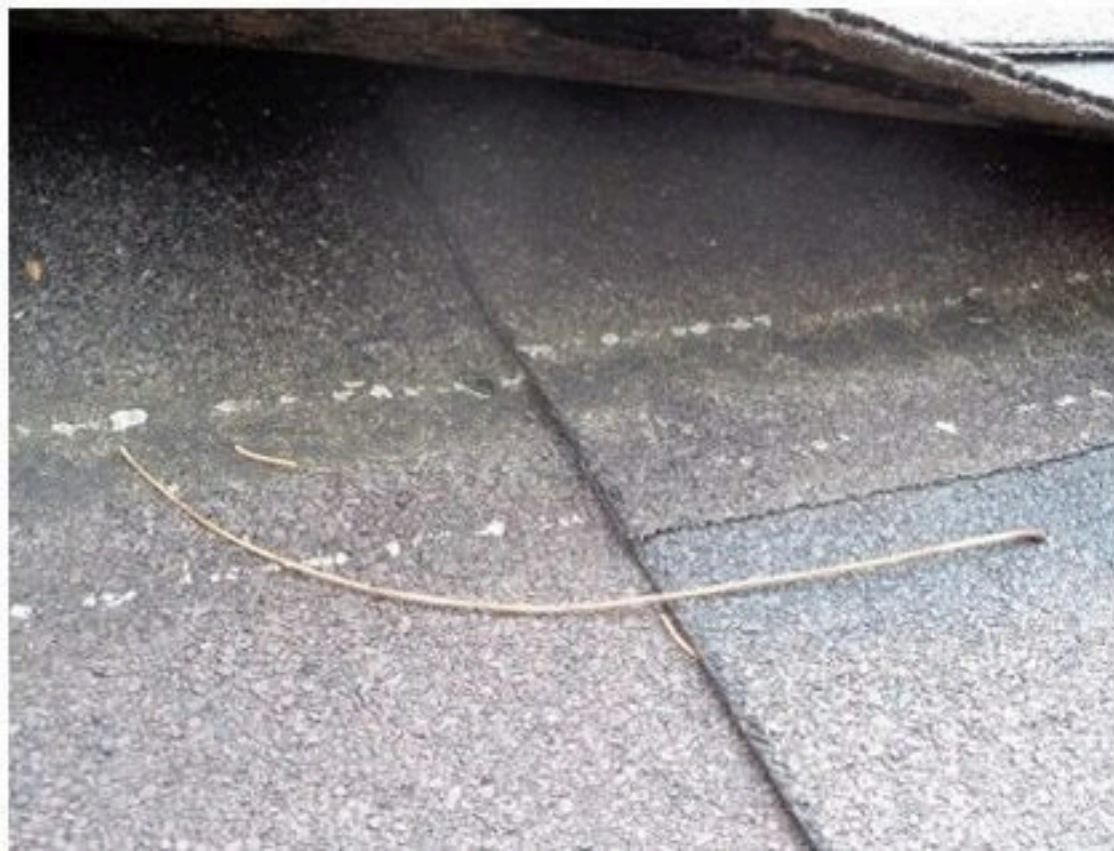
2) Nailing Pattern. Images below.

All manufacturers installation guides mandate that a nail be placed 3/4" back from the 'butt' ends of each full shingle.

In this installation, common at all exposures there is a lack of the required nails and nails too far away from the butt over all exposures.

This will result in the material blowing off in windy conditions.

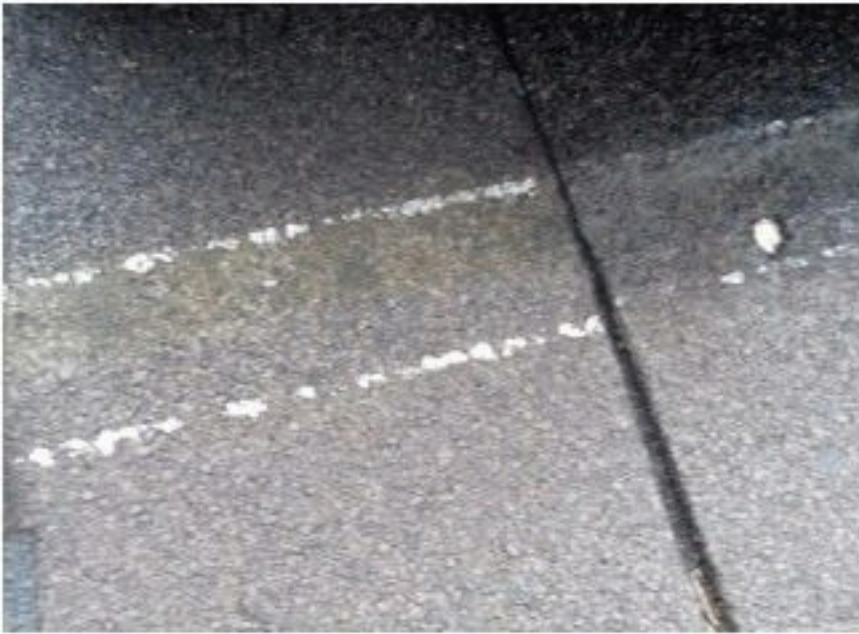
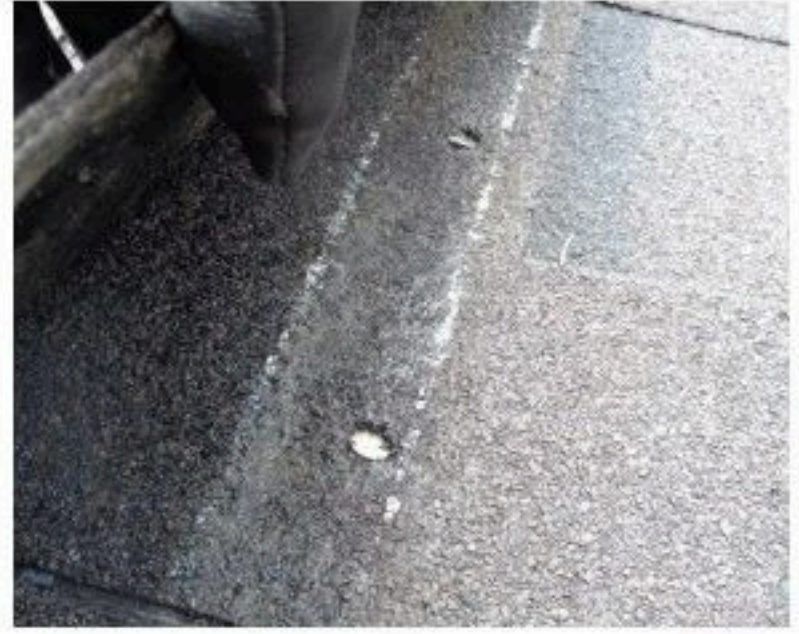
3) Nails are also required to be set straight and flush with the shingle surface; not deep and not 'proud'. In this installation the nails are set too deep. This also will result in material blowing off.

The images below show nails missing, nails set too deep and nails set at angles over all roof exposures.

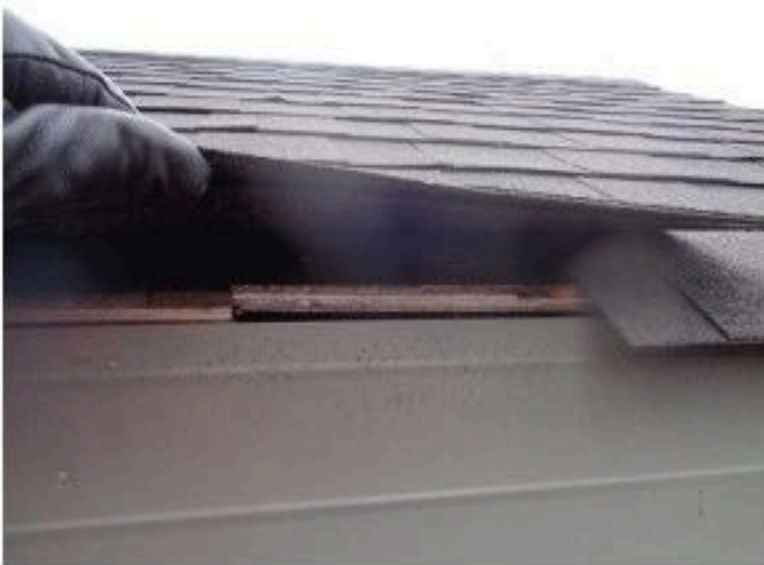
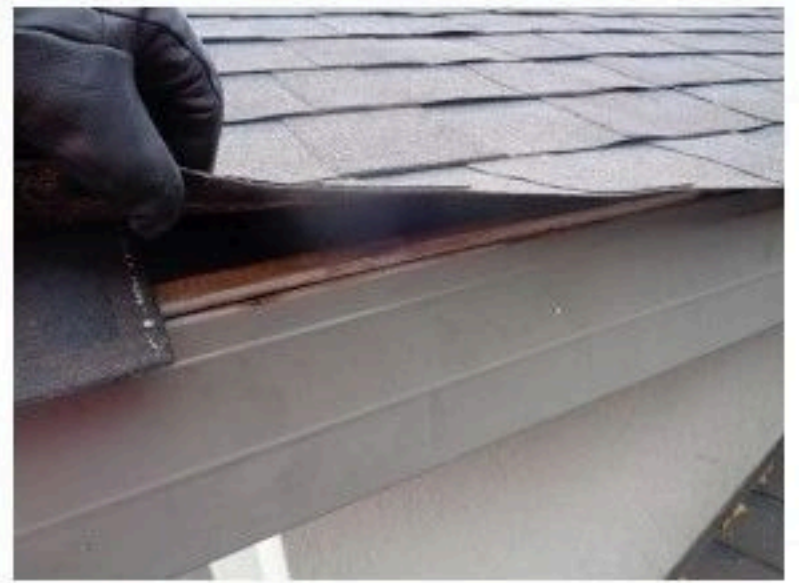
4) Starter Strip Shingles. In many places there is no new starter strip. At other locations the starter strip of the old roof was left in place. The plywood roof sheathing is exposed.

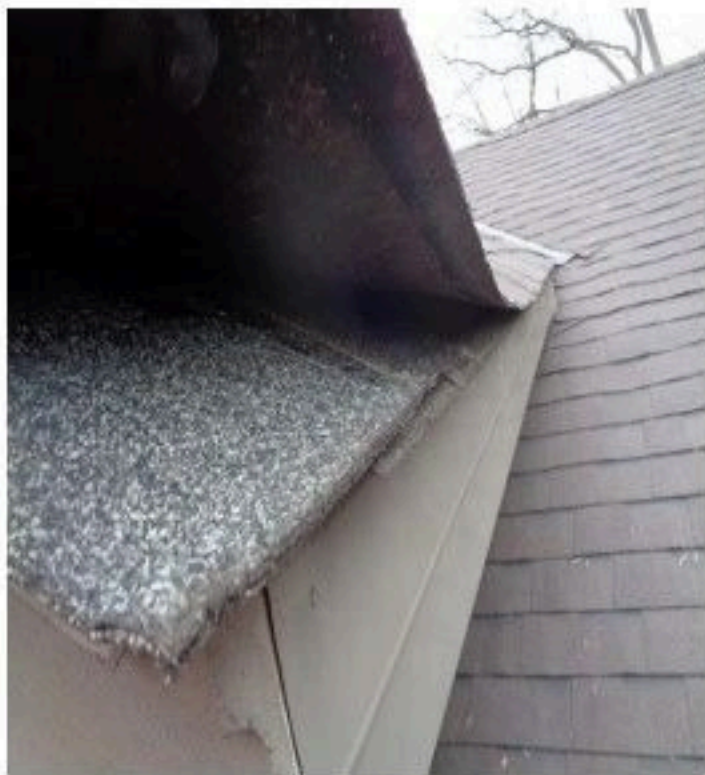
001

Image 001. Original different colour starter strip left in place.

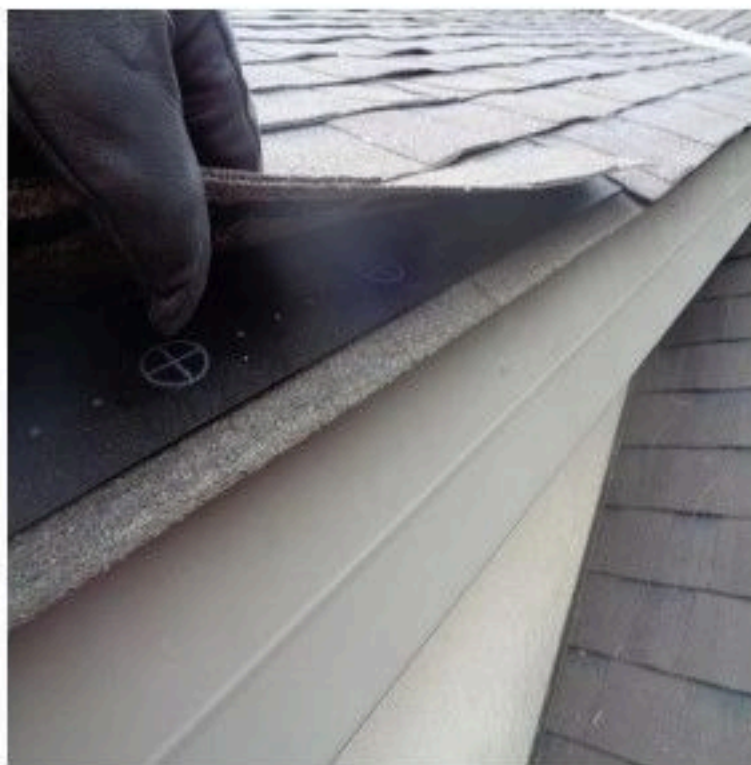
002

Image 002. New eaves protection on top of original starter strip.

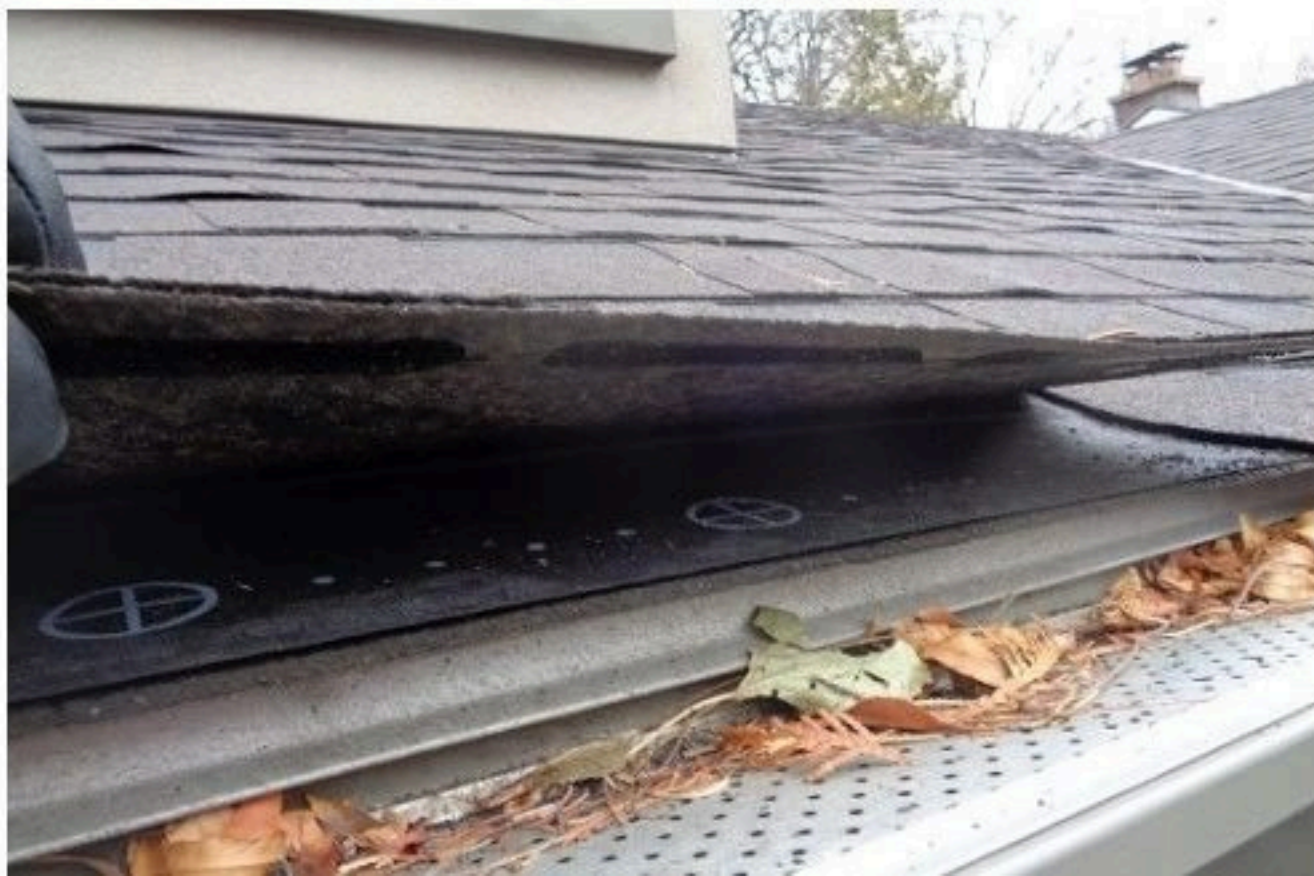
003

Image 003. No starter strip.

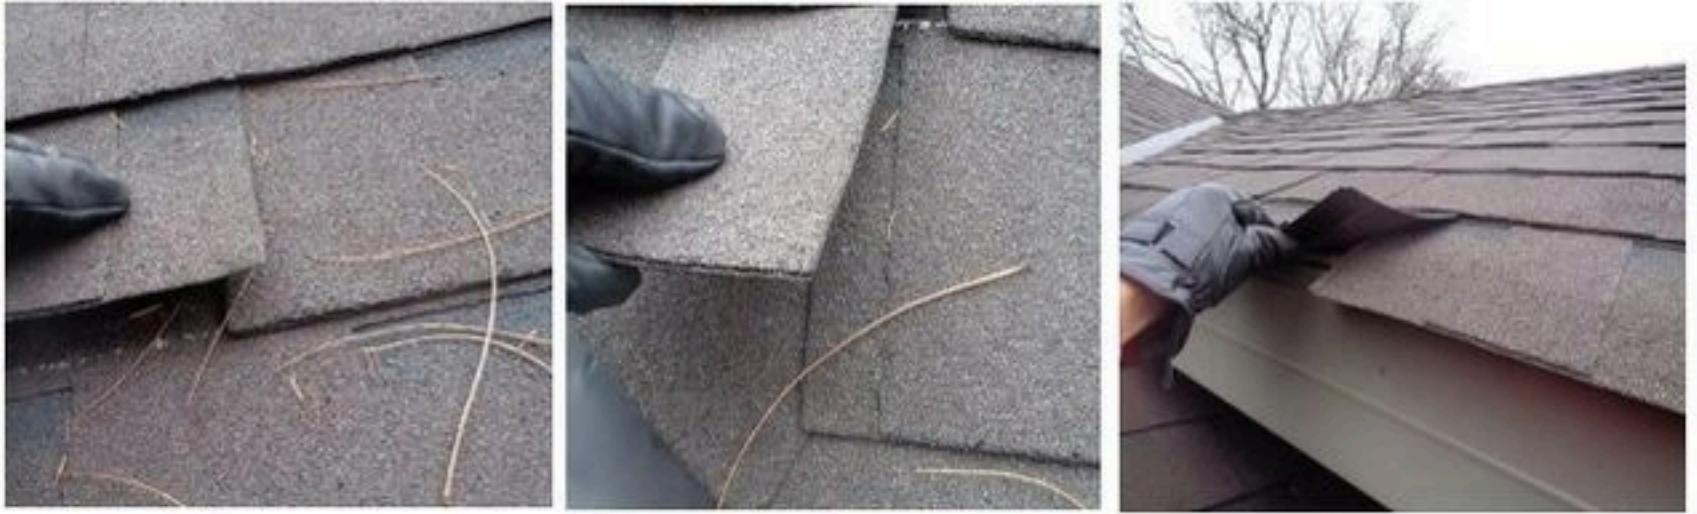
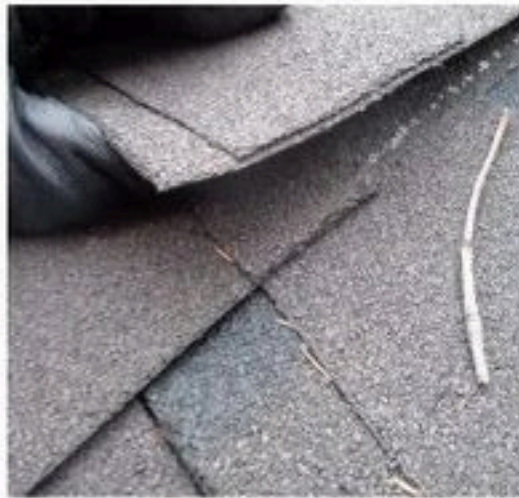
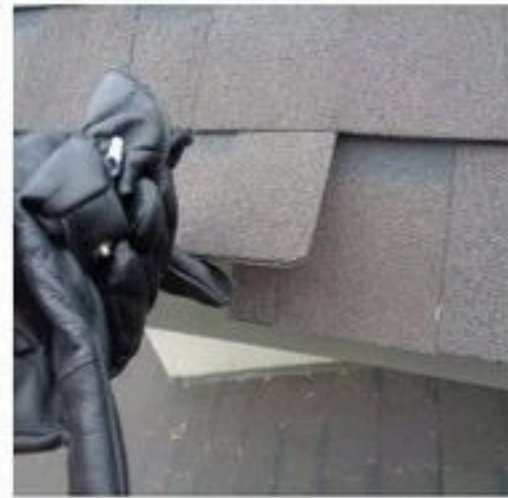
5) Images below. Shingles overlapped at 'butt ends'.
Typical at all exposures.

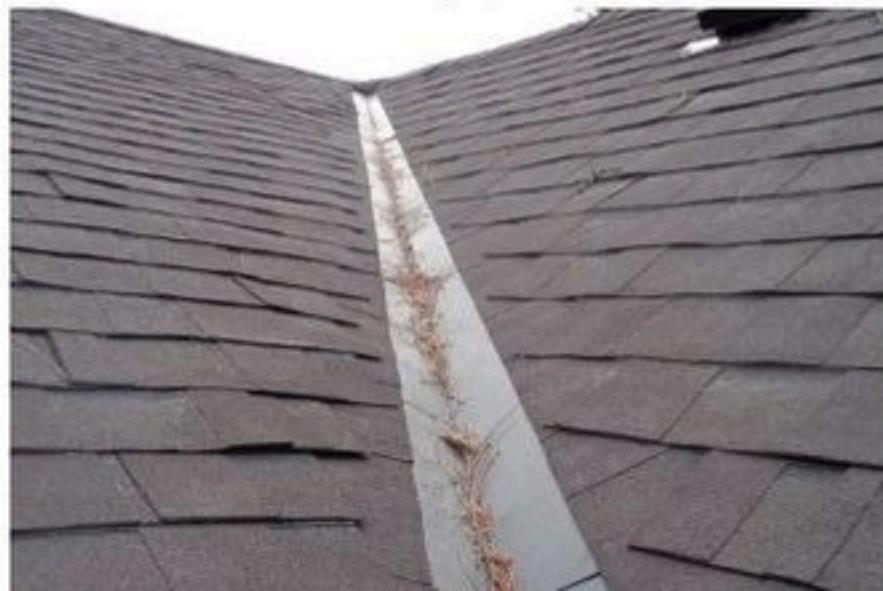
Valley

- 1) Sheet metal of 24" girth installed, centred, and 12" up each side.
- 2) A starter strip shingle, comprising a full shingle cut length wise in half with the tab half discarded, set bottom to top of the valley to cover the metal edge.

Shingle application must commence at the edges of the roof and terminate at the valley, covering the starter strip.

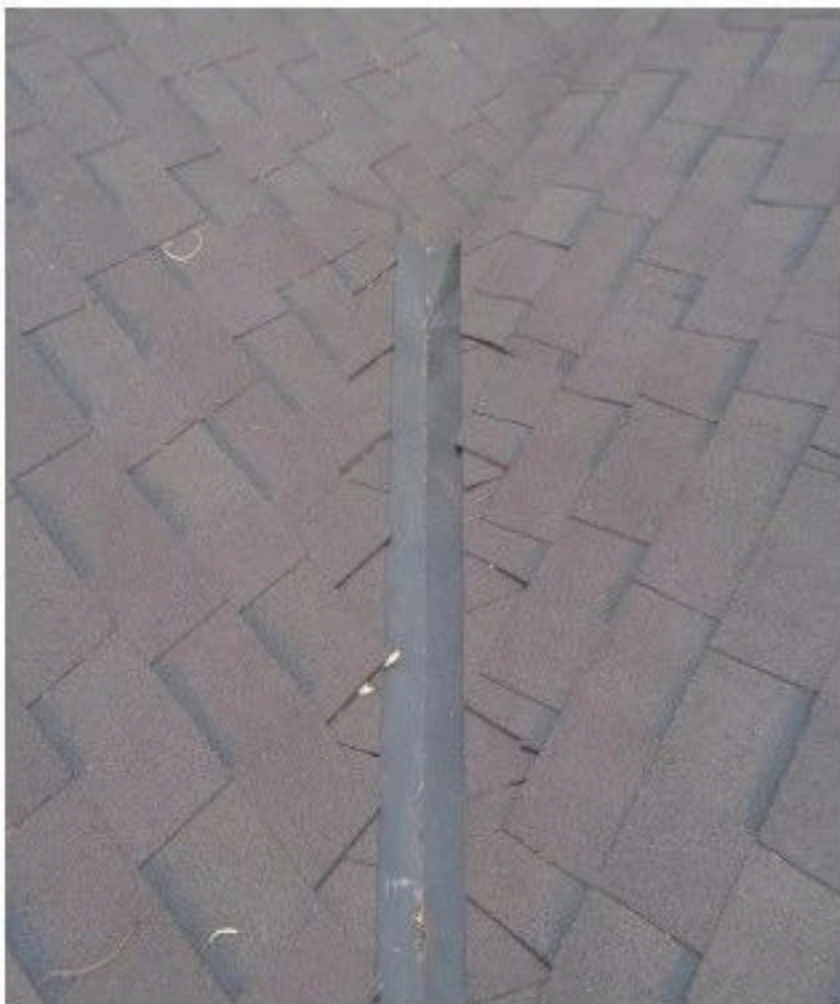
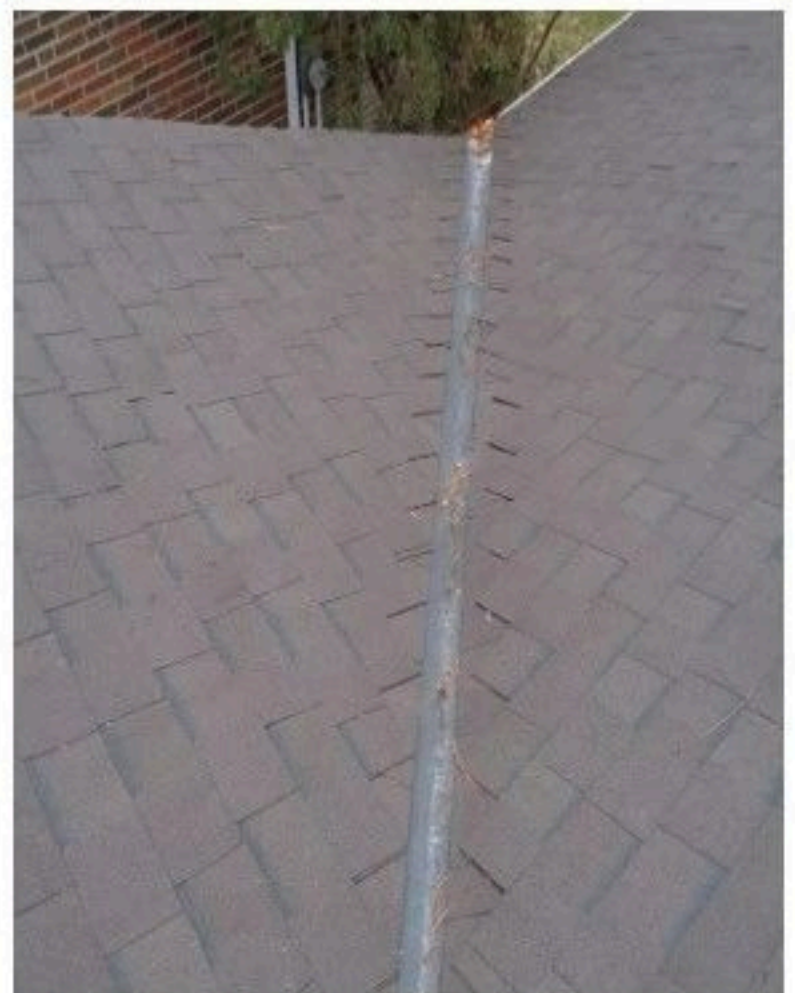
Here, a full shingle was installed as a starter strip and the field shingles started at the valley, hence the appearance shown in the images below. Each valley construction is entirely incorrect.

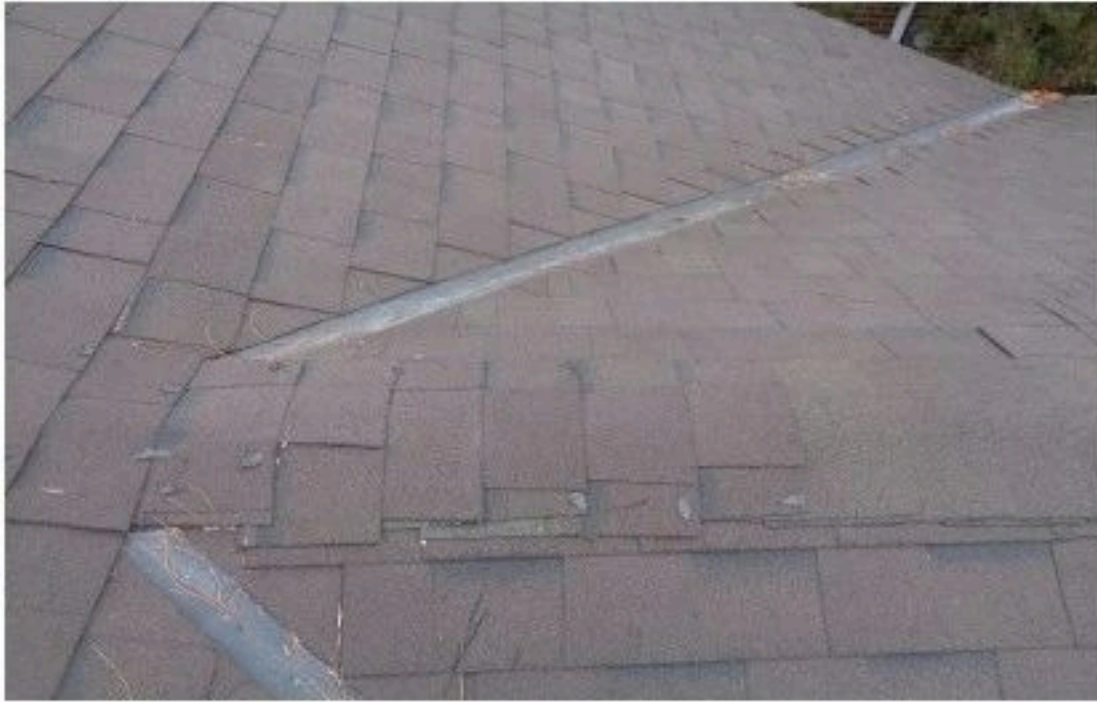
004

7) Image 004. Ridge Capping'

A separate type of shingle is used for the capping. In this case they ran out of proper caps and used shingles meant for the field of the roof.

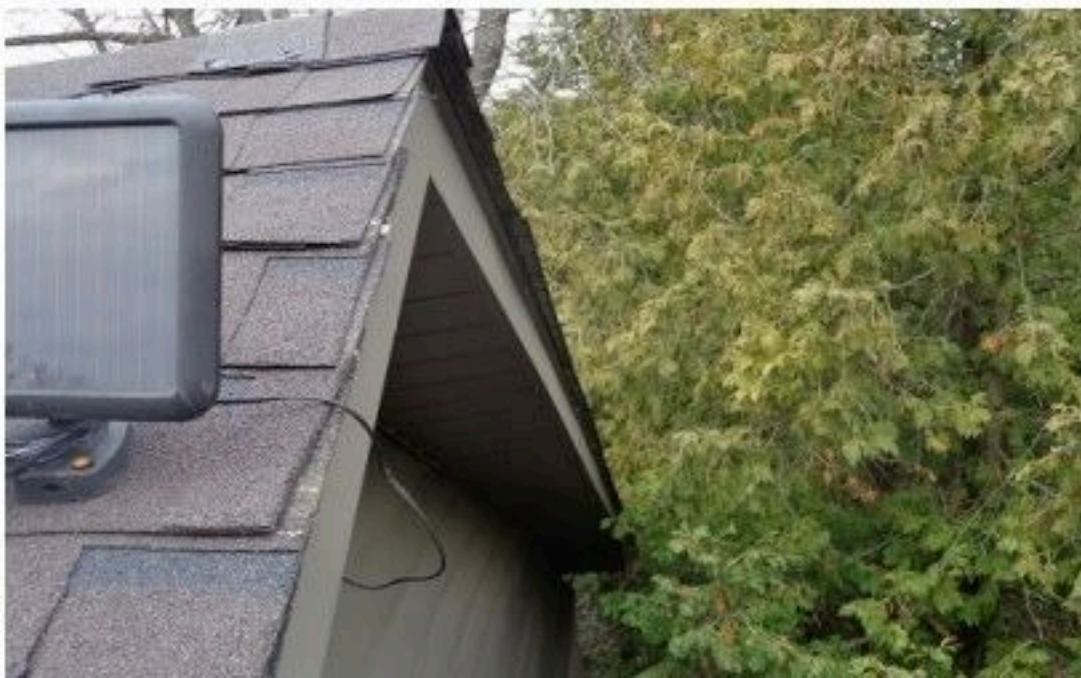
005

Image 005. The tringe edge is called the 'rake edge and the shingles should be trimmed to overhang 1/2" to 3/4" maximum. The image shows and overlap of 1/2" to 3"
