# INDEPENDENT ROOF INSPECTION SERVICES

## ROOF INSPECTION REPORT MAPLE AVE.

MARCH 14 2023

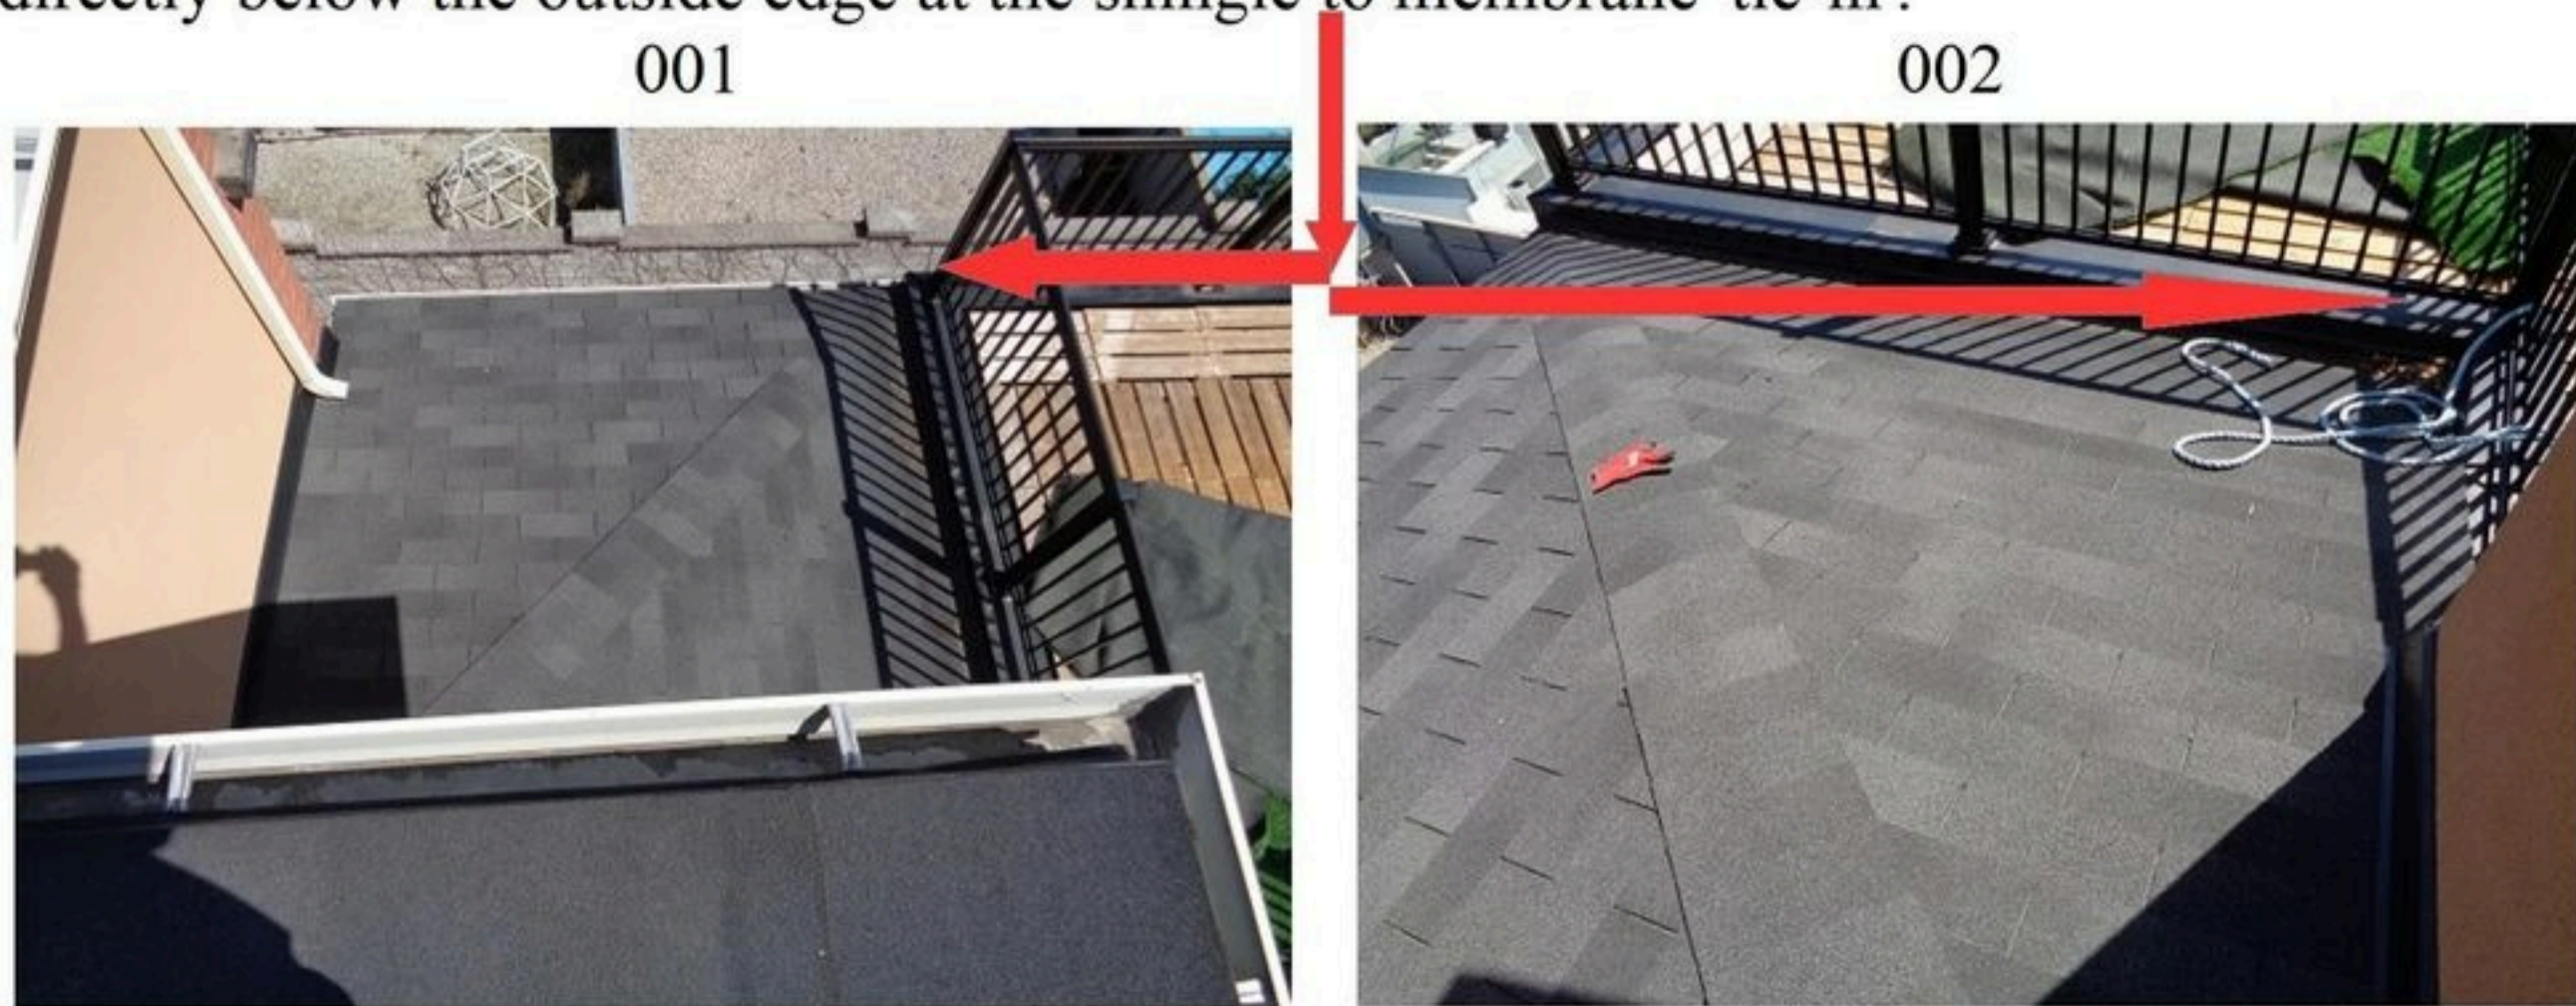
Images 001 and 002. The shingle roofing is sloped and drains to the flat roof structure. The leak is directly below the outside edge at the shingle to membrane 'tie-in'.

The flat roof membrane continues 'up and over' the roof curb and is set beneath the adjacent shingle roofing.

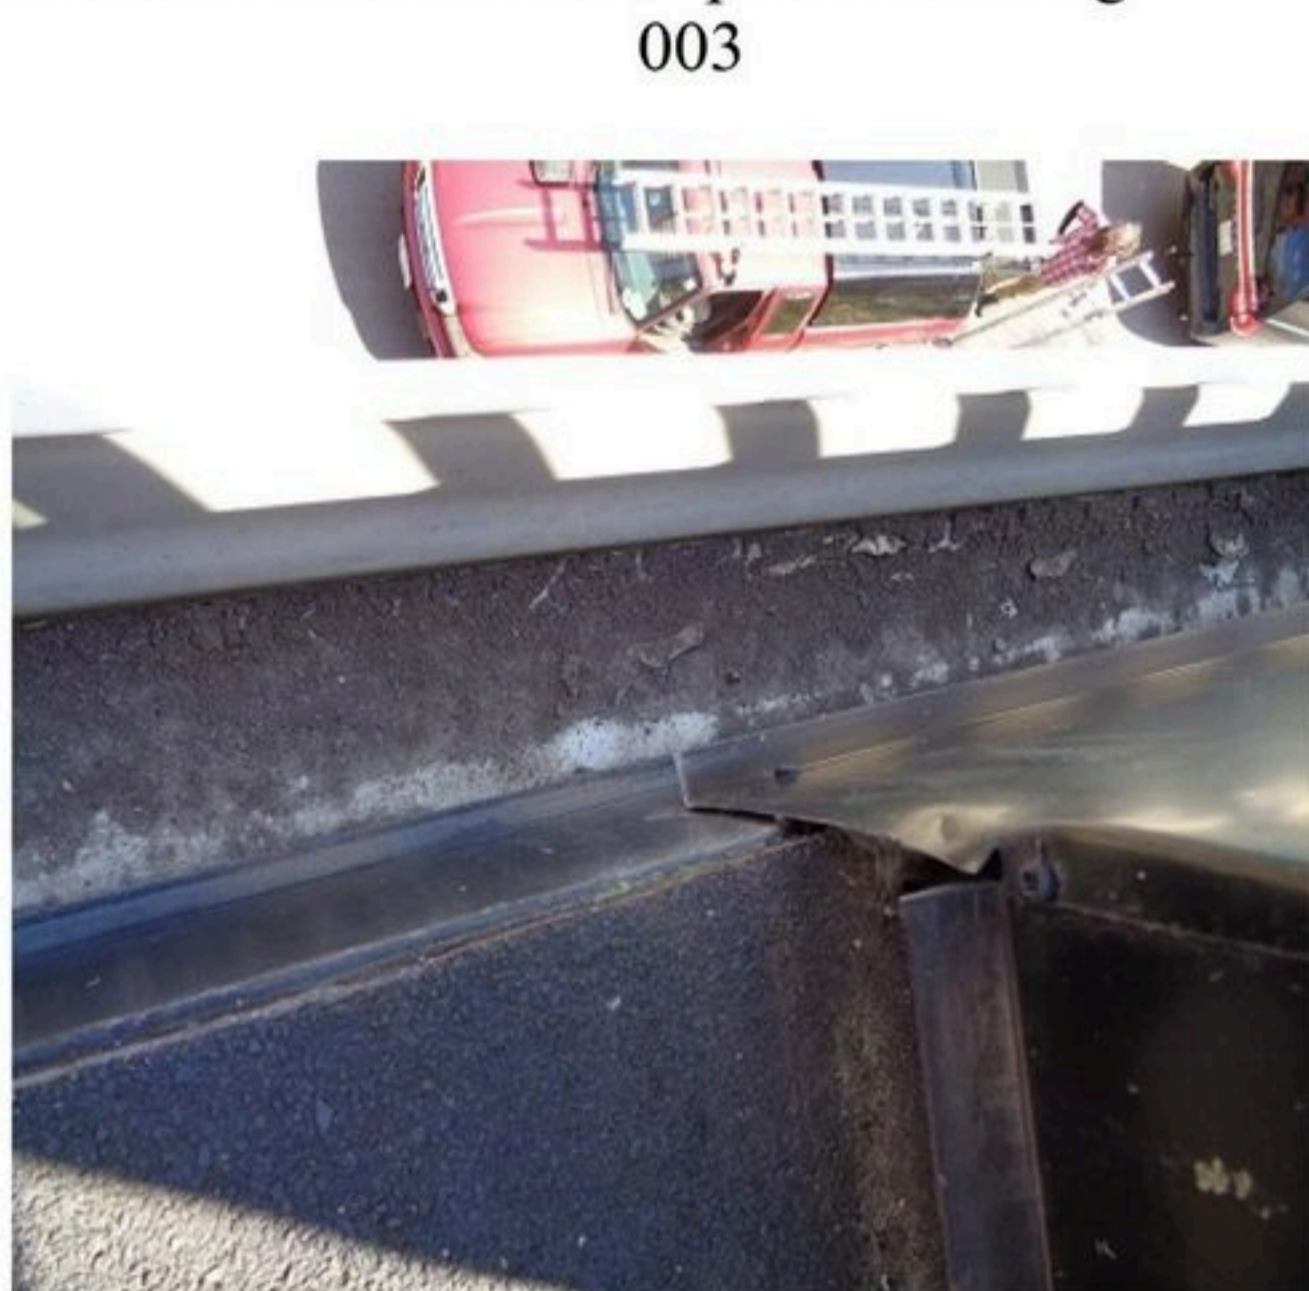
Images 003 and 004. Outside corner, curb to shingle slope/membrane 'tie-in'. There is a metal 'drip edge' which drains into an eaves trough. The membrane from the roof curb is adhered to it and then continues beneath the shingles.

The sheet metal corner requires caulking.

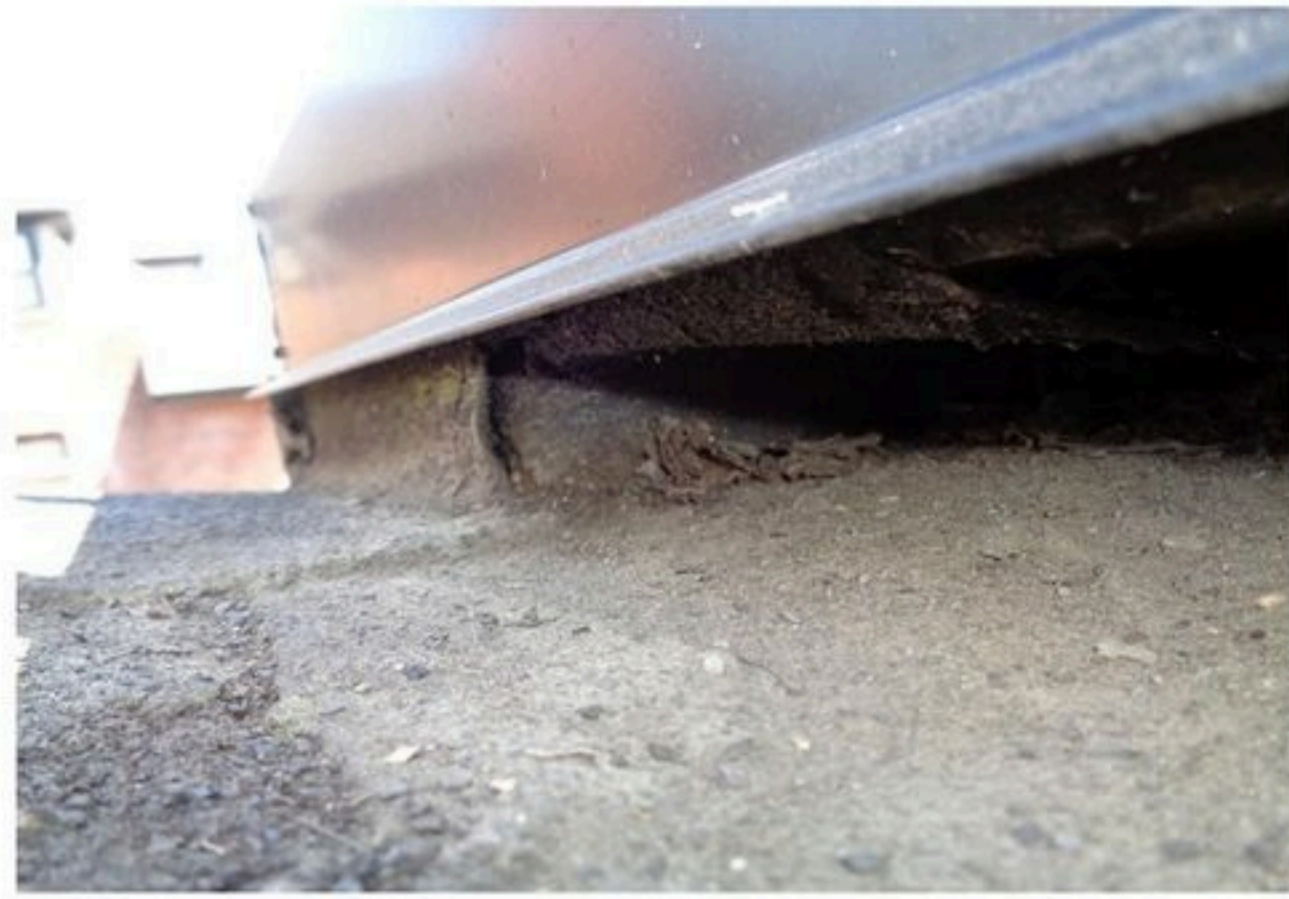
Images 005 and 006. There is an open seam in the membrane roofing

- 1) Open membrane seam ('fishmouth'). Images 005 and 006.
- 2) Membrane not adhered. Images 007 and 008.
- 3) Void at brick/stucco interface. Images 009 and 010

- 1) Seal membrane at fishmouth.
- 2) Adhere the membrane.
- 3) Mortar or caulk the brick stucco interface.

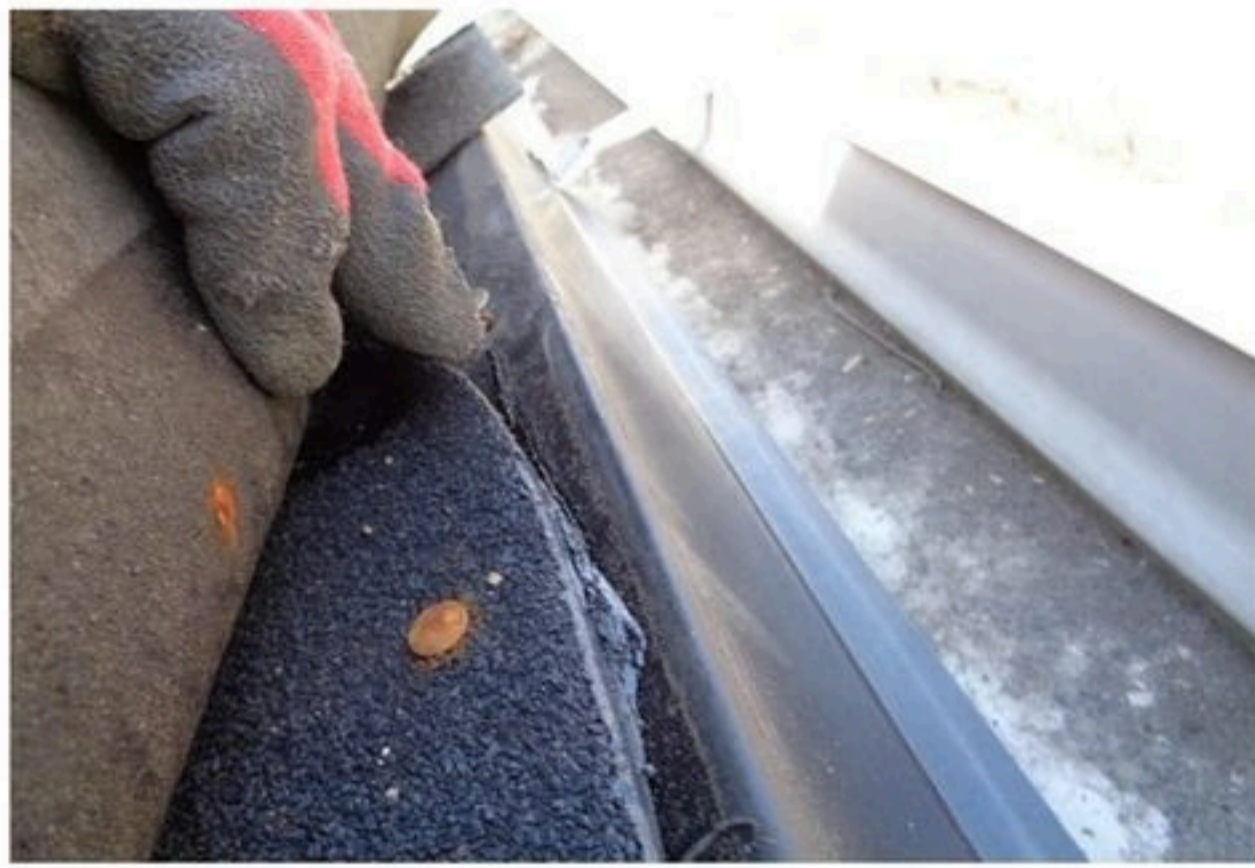
Image 007 and 008. Shingle to membrane tie-in. Membrane not adhered to the drip edge.

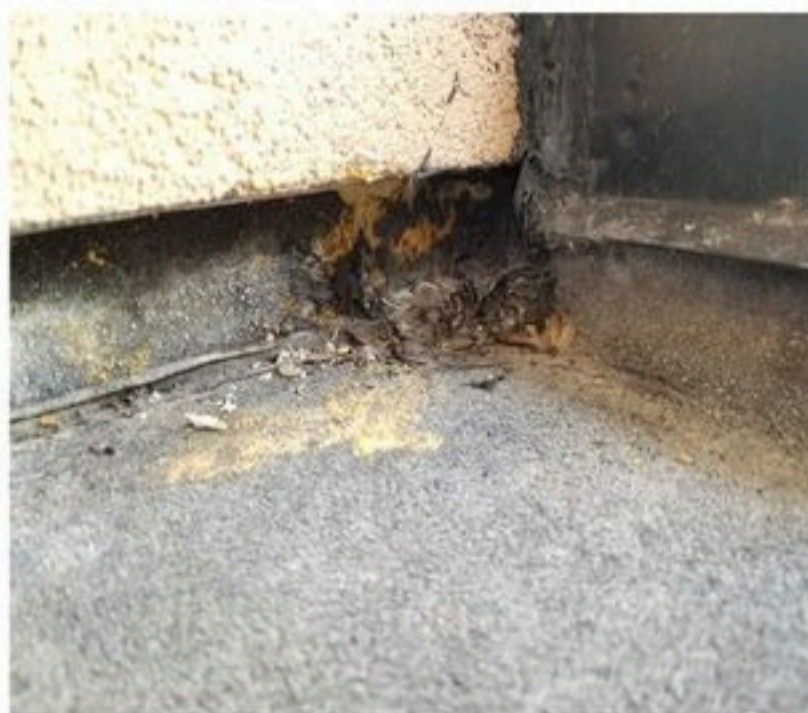
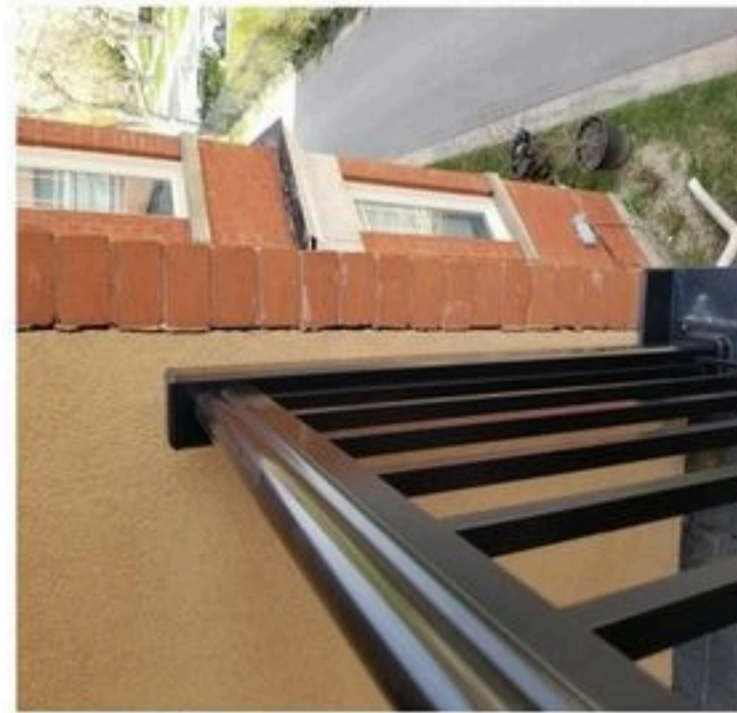
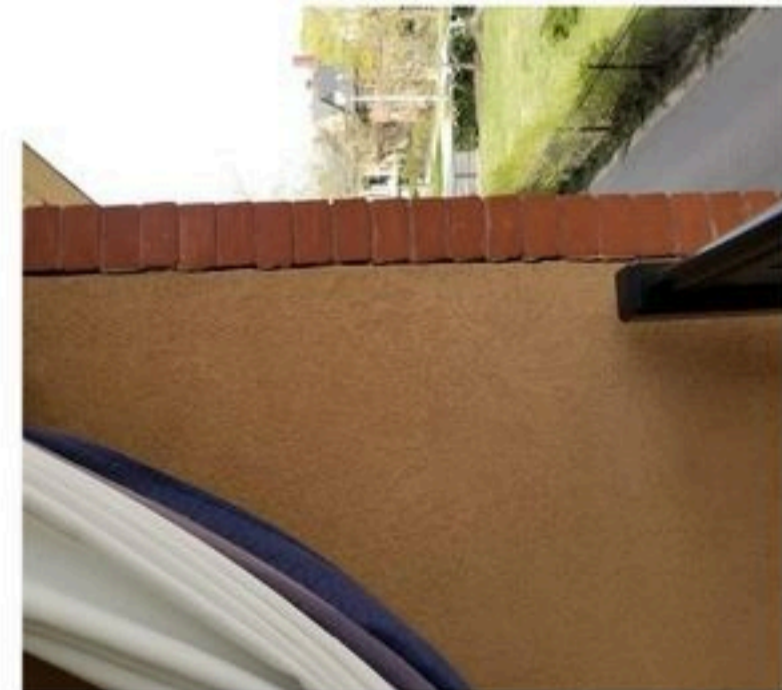
Image 009 and 010.

These images show an opening between the brickwork and the stucco where water enters the systems below.

Point of water entry.

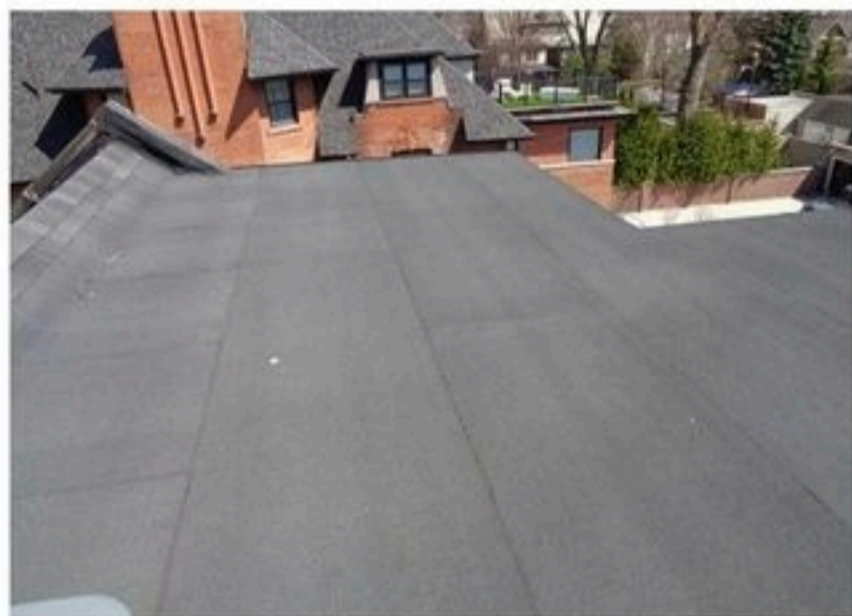
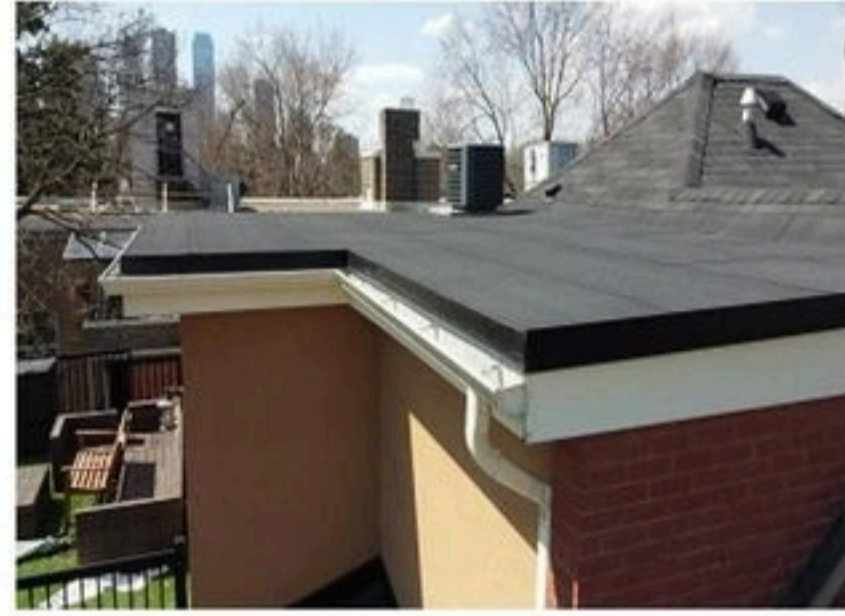
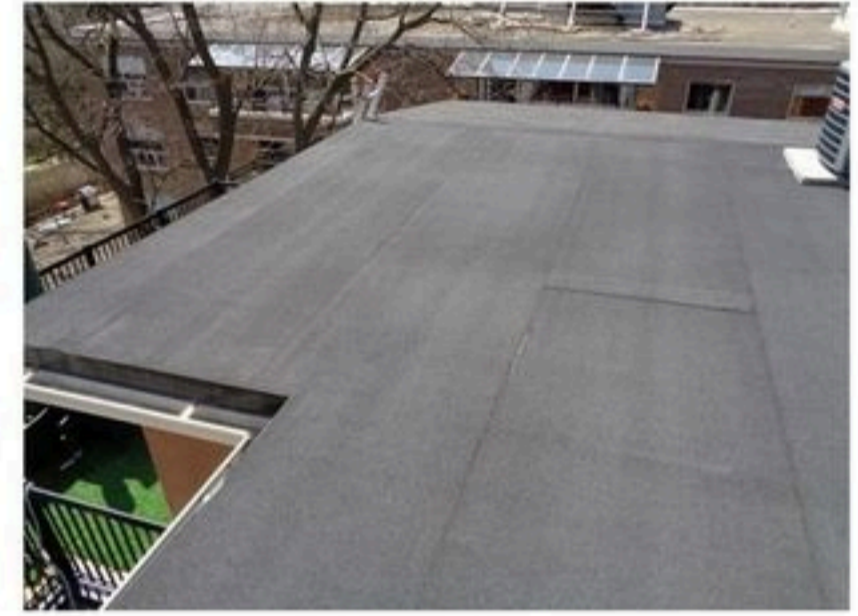
South exposure, flat roof. No deficiencies.

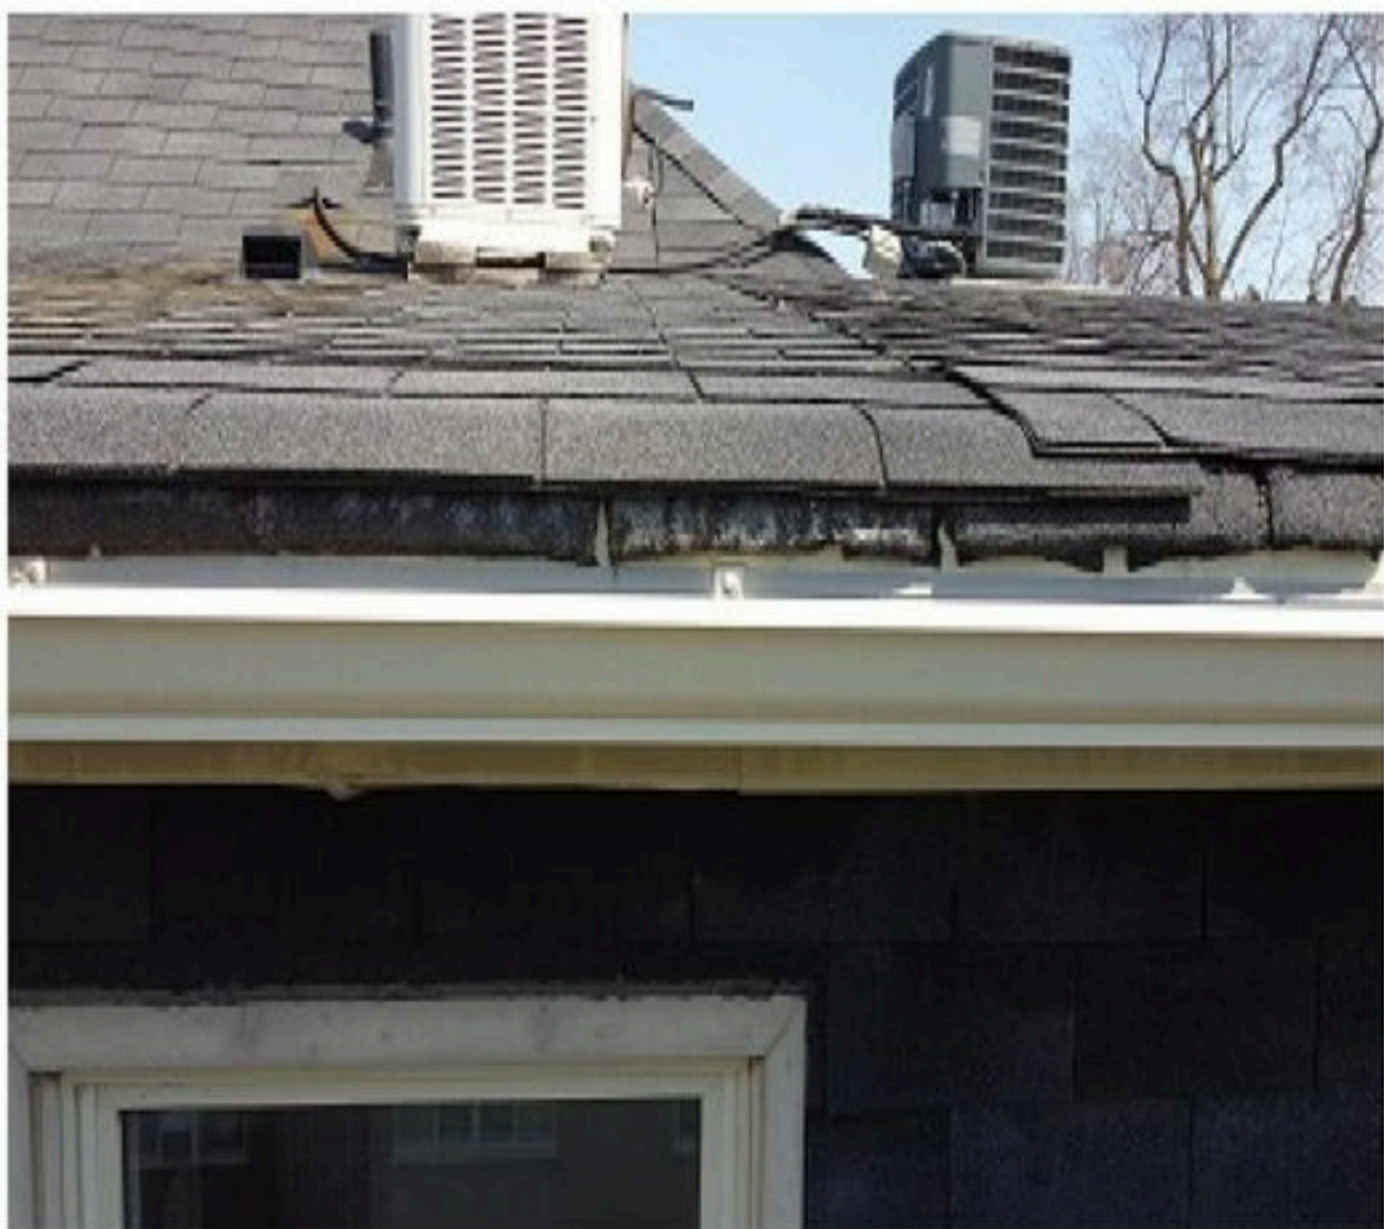
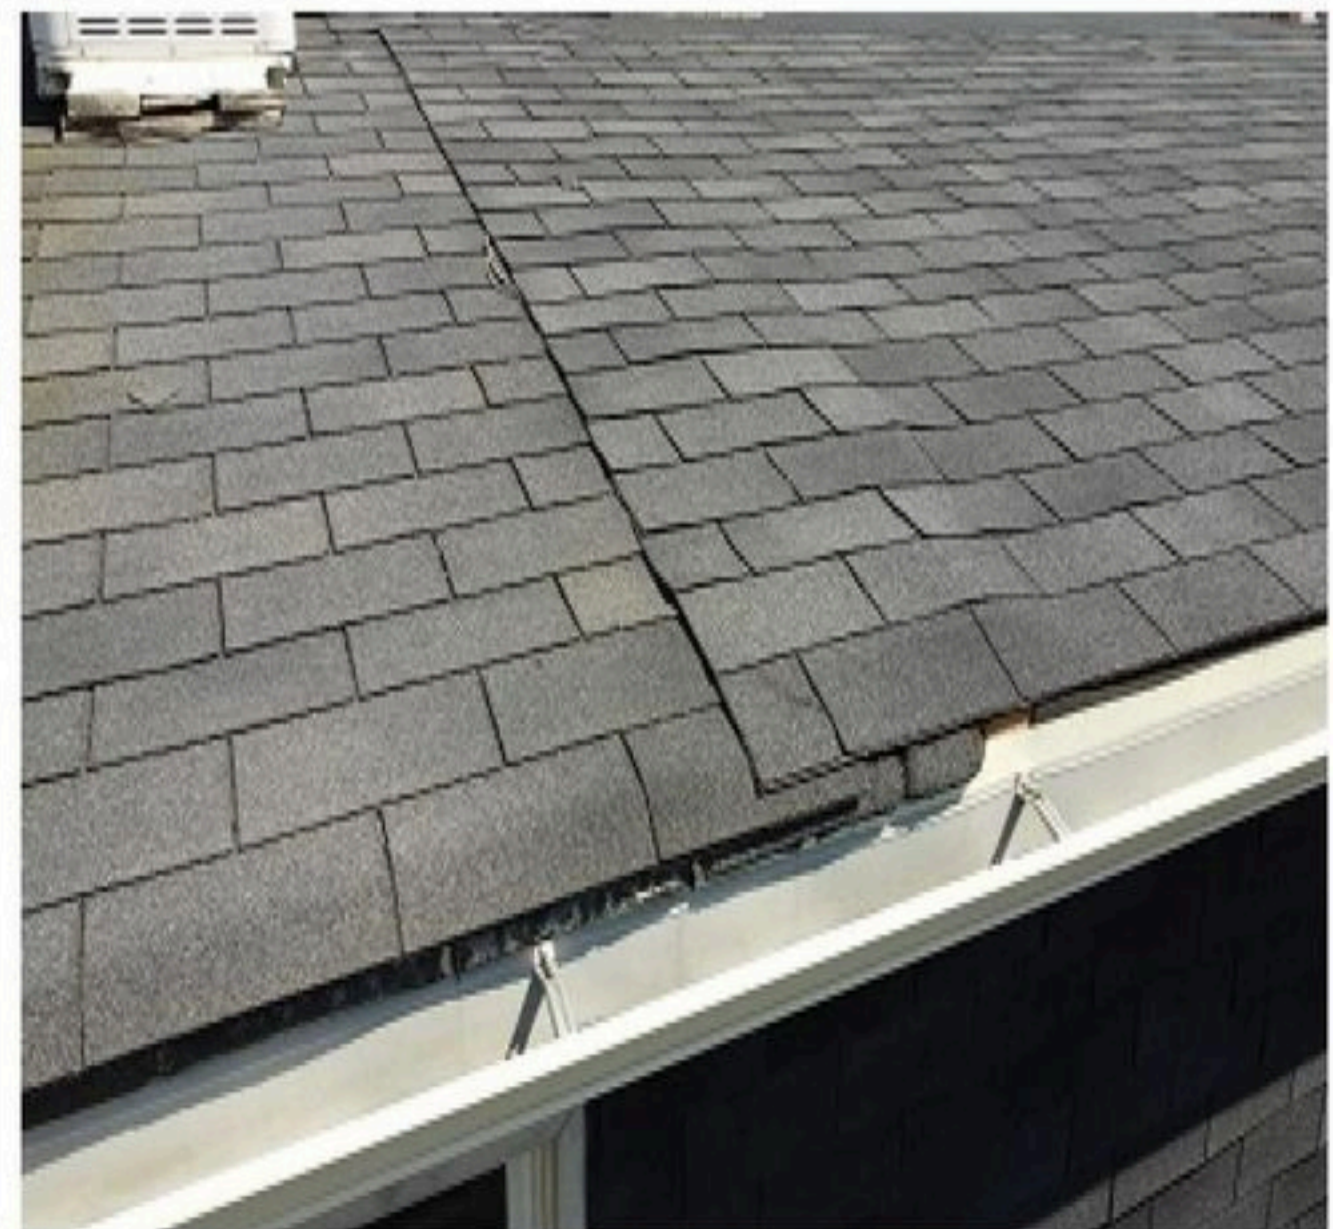
WEST SIDE EAVE EDGE. Upper main roof.

The images below show that there are two layers of shingles extant.

Rust stains from where the A/C unit power exits, shows that water is entering the system.

There is exposed wood fascia board.

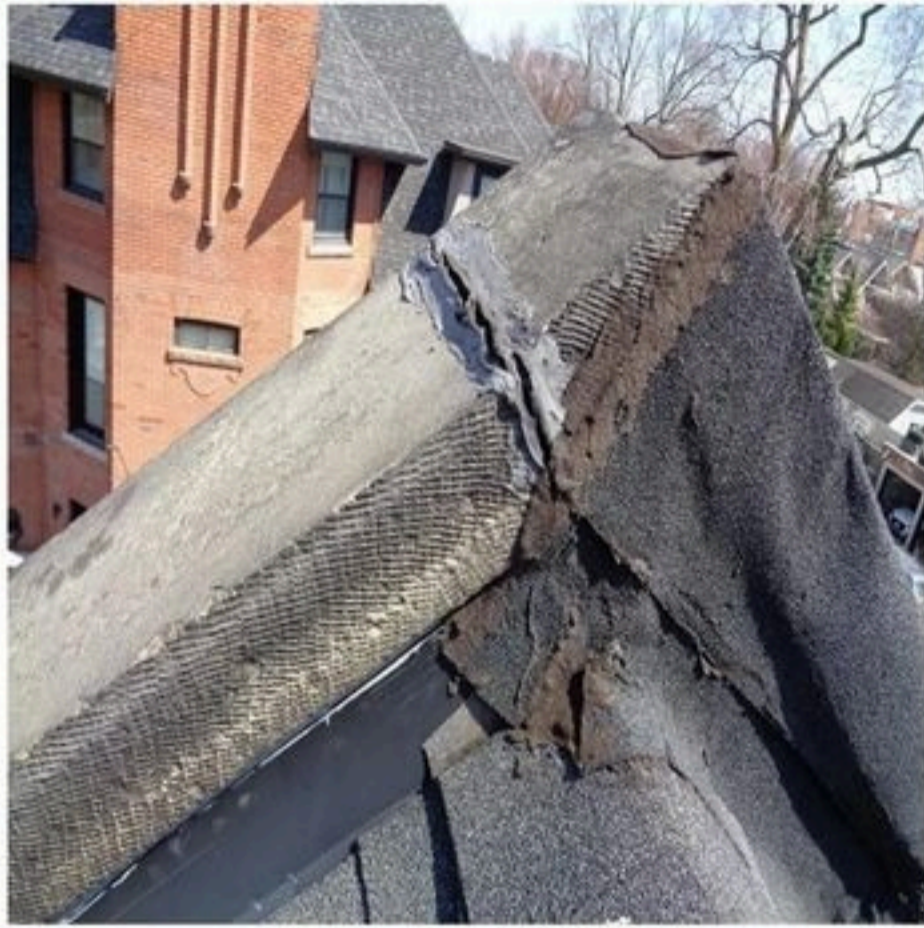
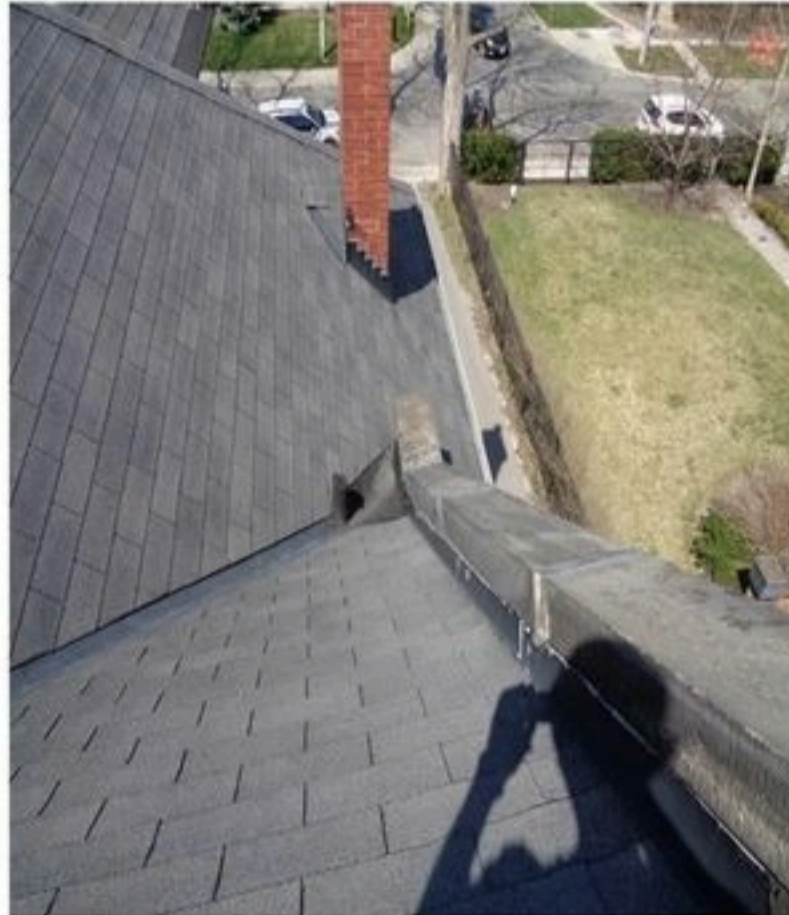
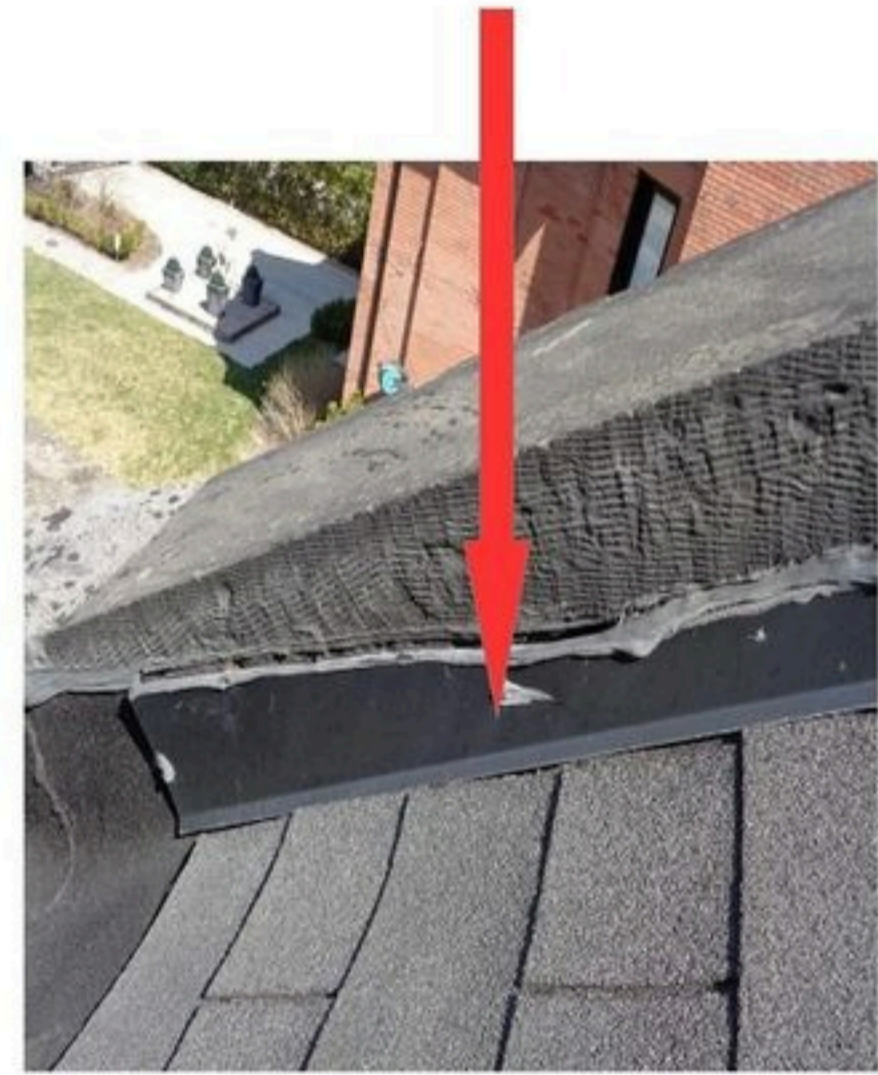
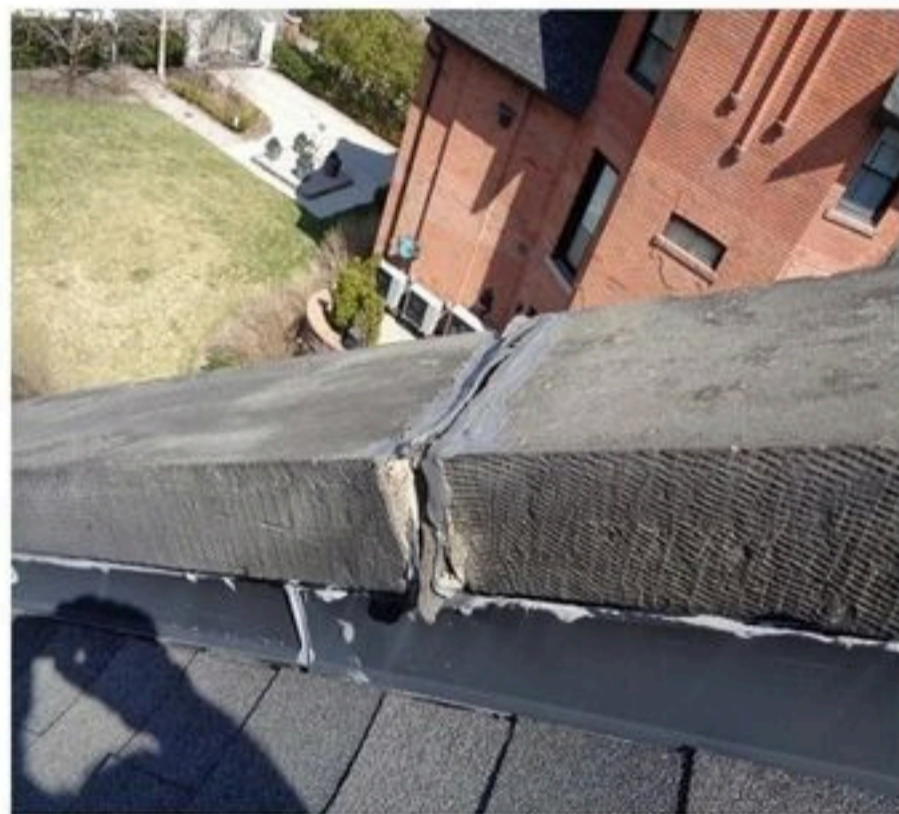
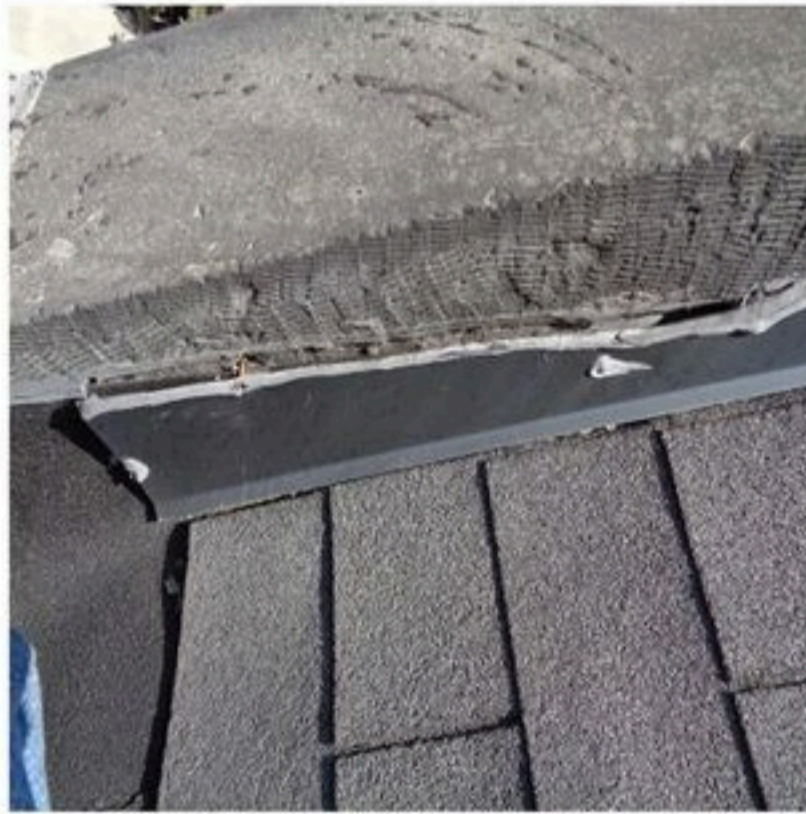
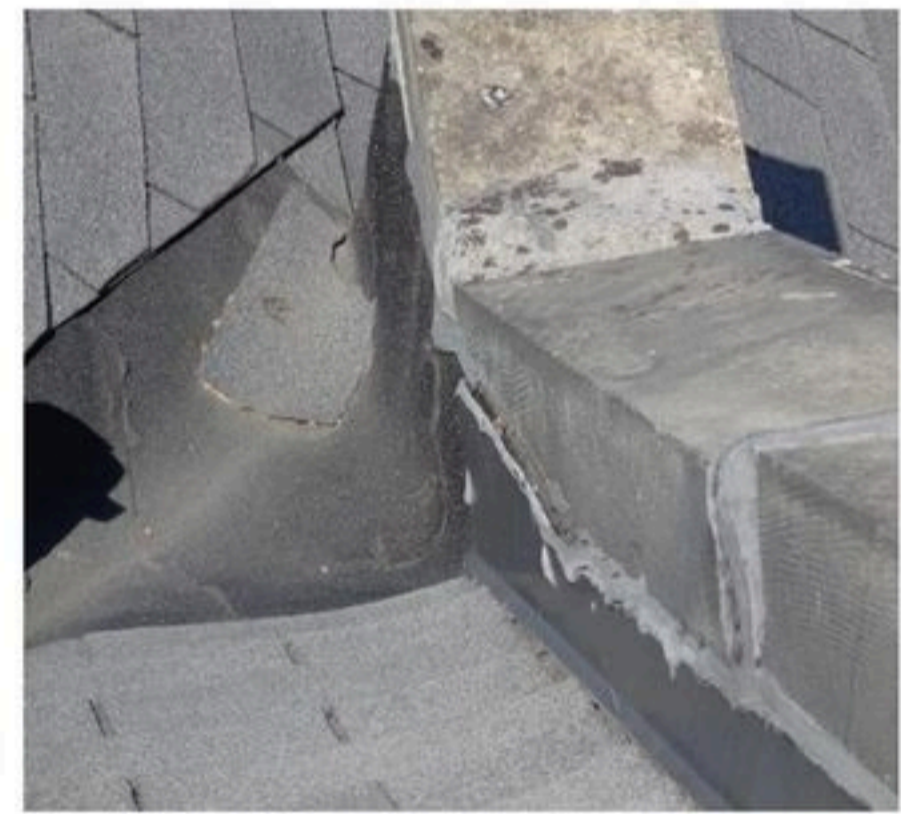
**PARAPET EAST SIDE..**

The flat roof membrane termination at the top of the parapet is wrinkled and insecure.

The mortar at the parapet stonework has crumbled away.

The sheet metal flashing is loose and open to water ingress.

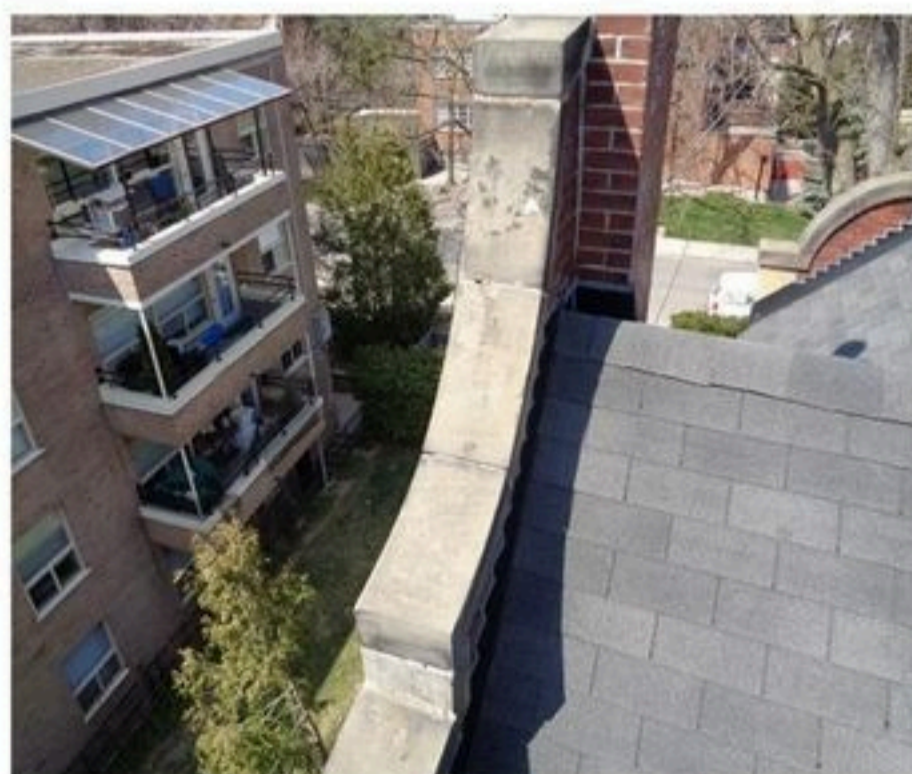
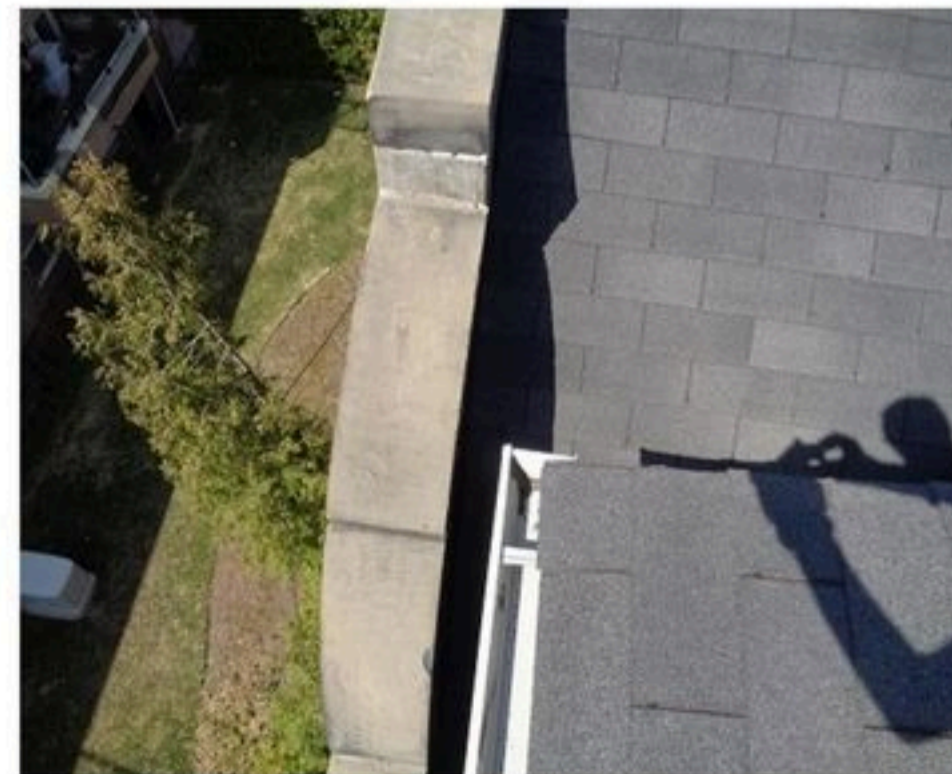
**HIGH PARAPET WEST SIDE. Some deterioration of the mortar joints.**

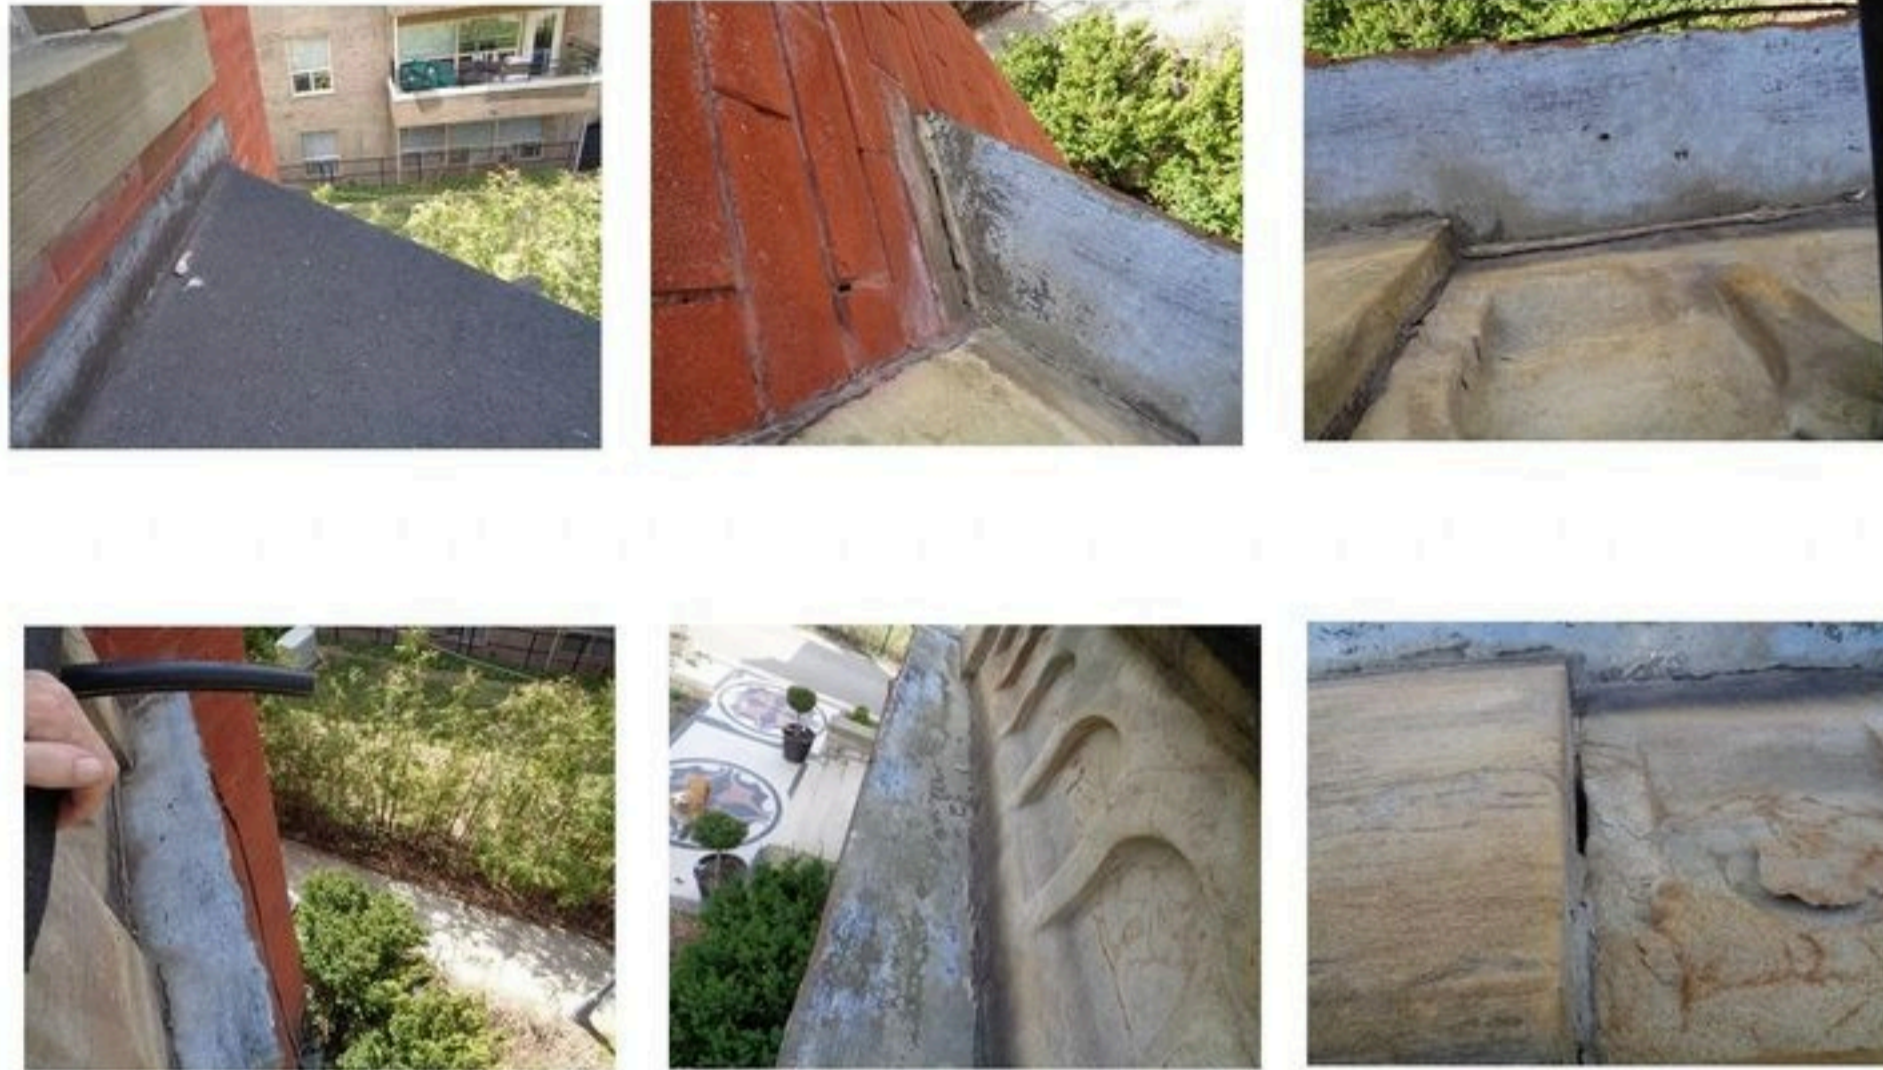
**BAY WINDOW, NORTH EXPOSURE.**

Images below. A modified bitumen membrane adhered to an original sheet metal roof with metal capping of the stone work below. Some deterioration at the mortar joints.

We recommend that all bay window and canopy roofs be replaced.
