INDEPENDENT ROOF INSPECTION SERVICES

ROOF INSPECTION REPORT

ETOBICOKE ONT.

MAY 30 2023

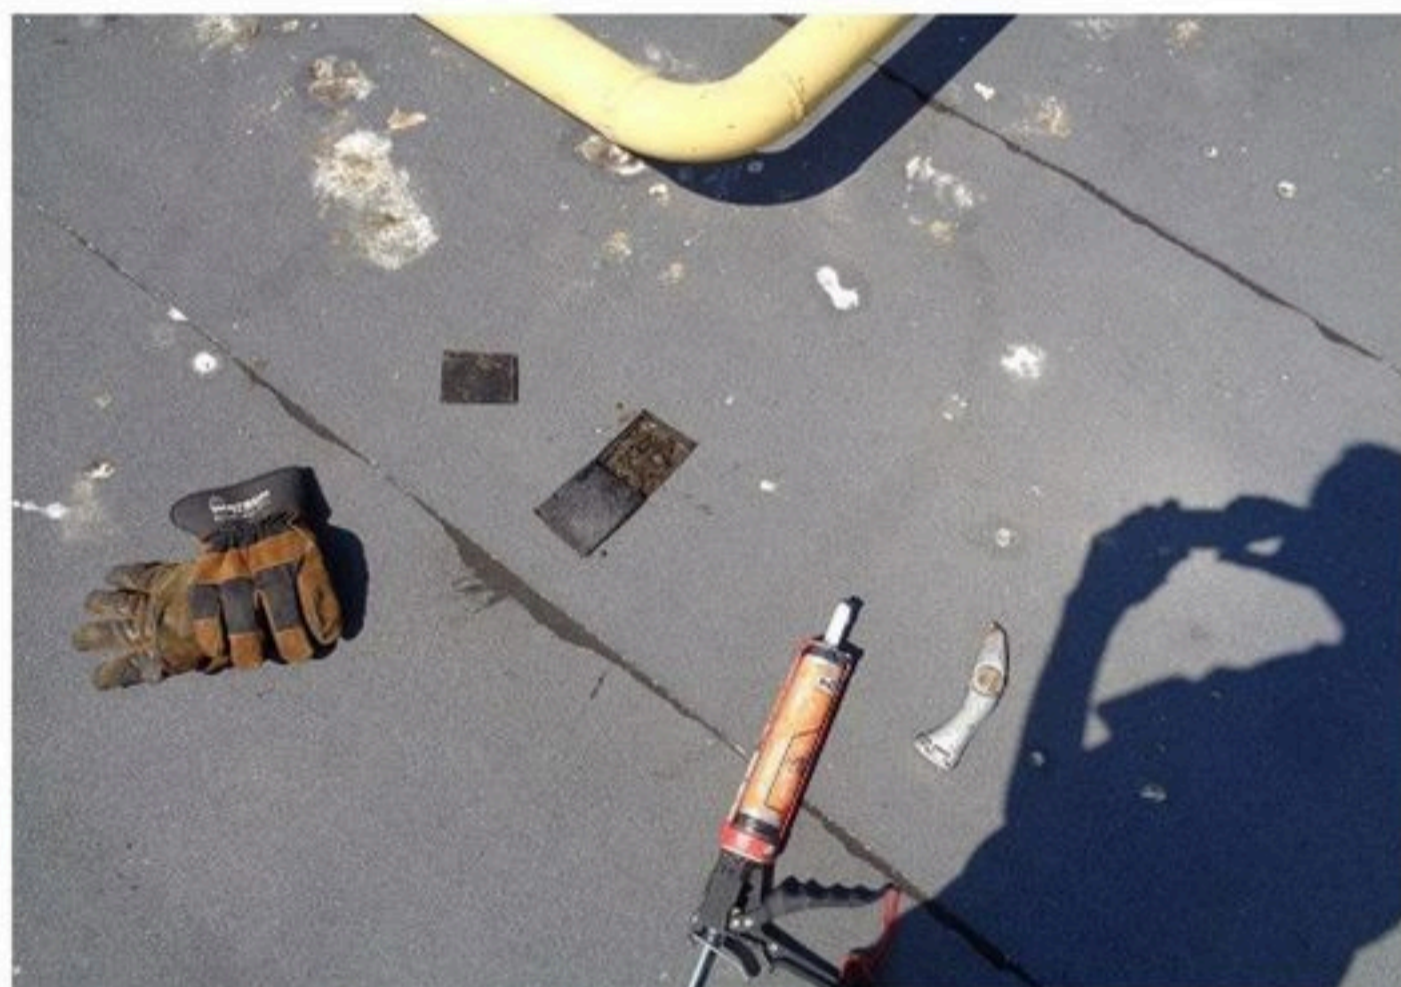
Images 001 and 002. No new insulation. Wet 4-ply ply felt membrane (tar and gravel) still in place.

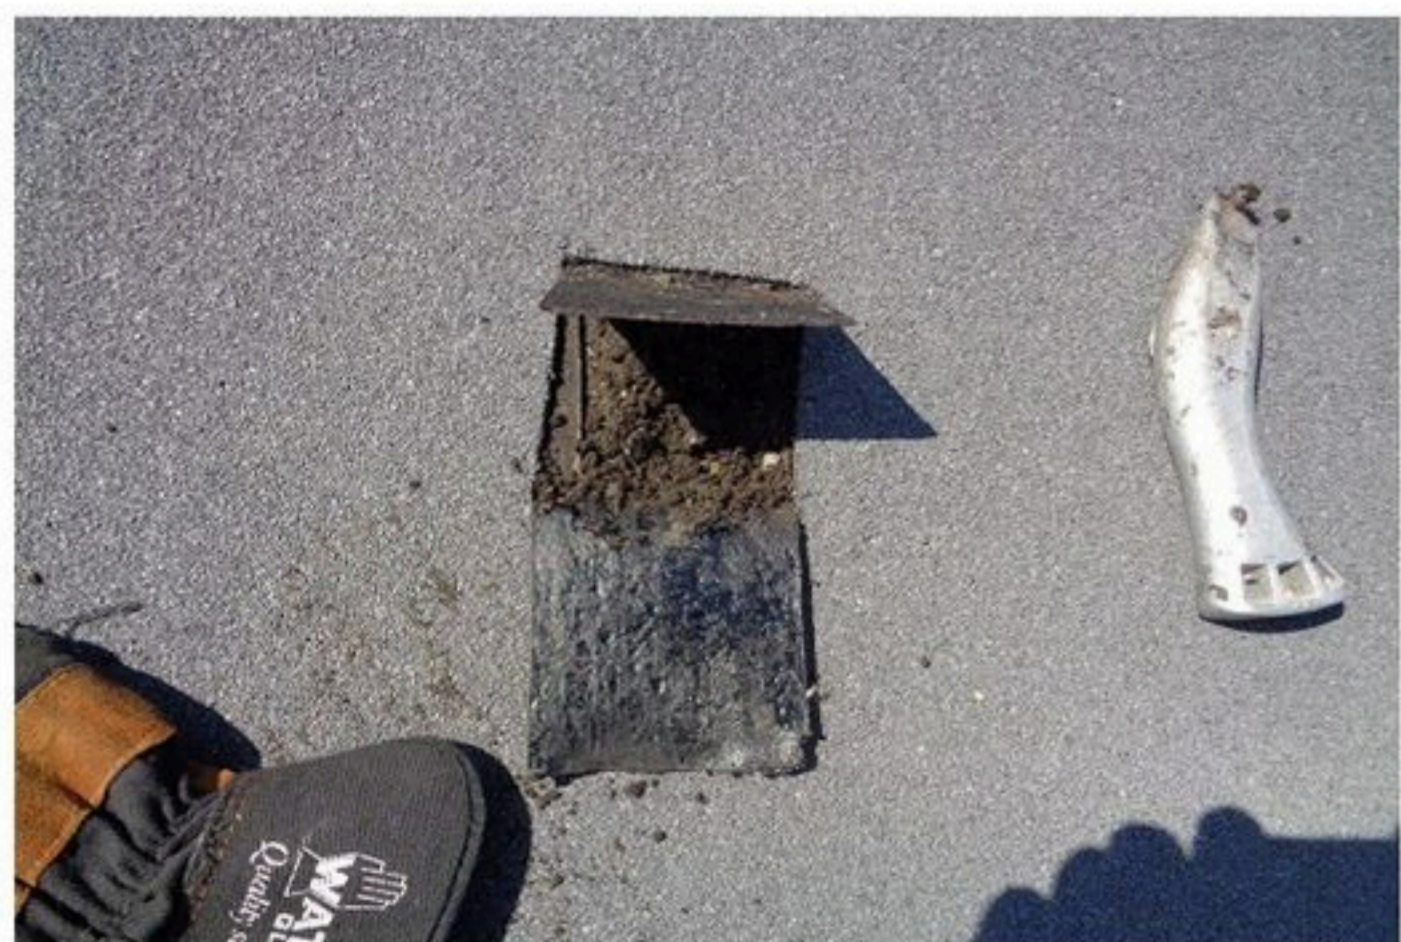
Images 003 and 004. Pre-existing roof extant.

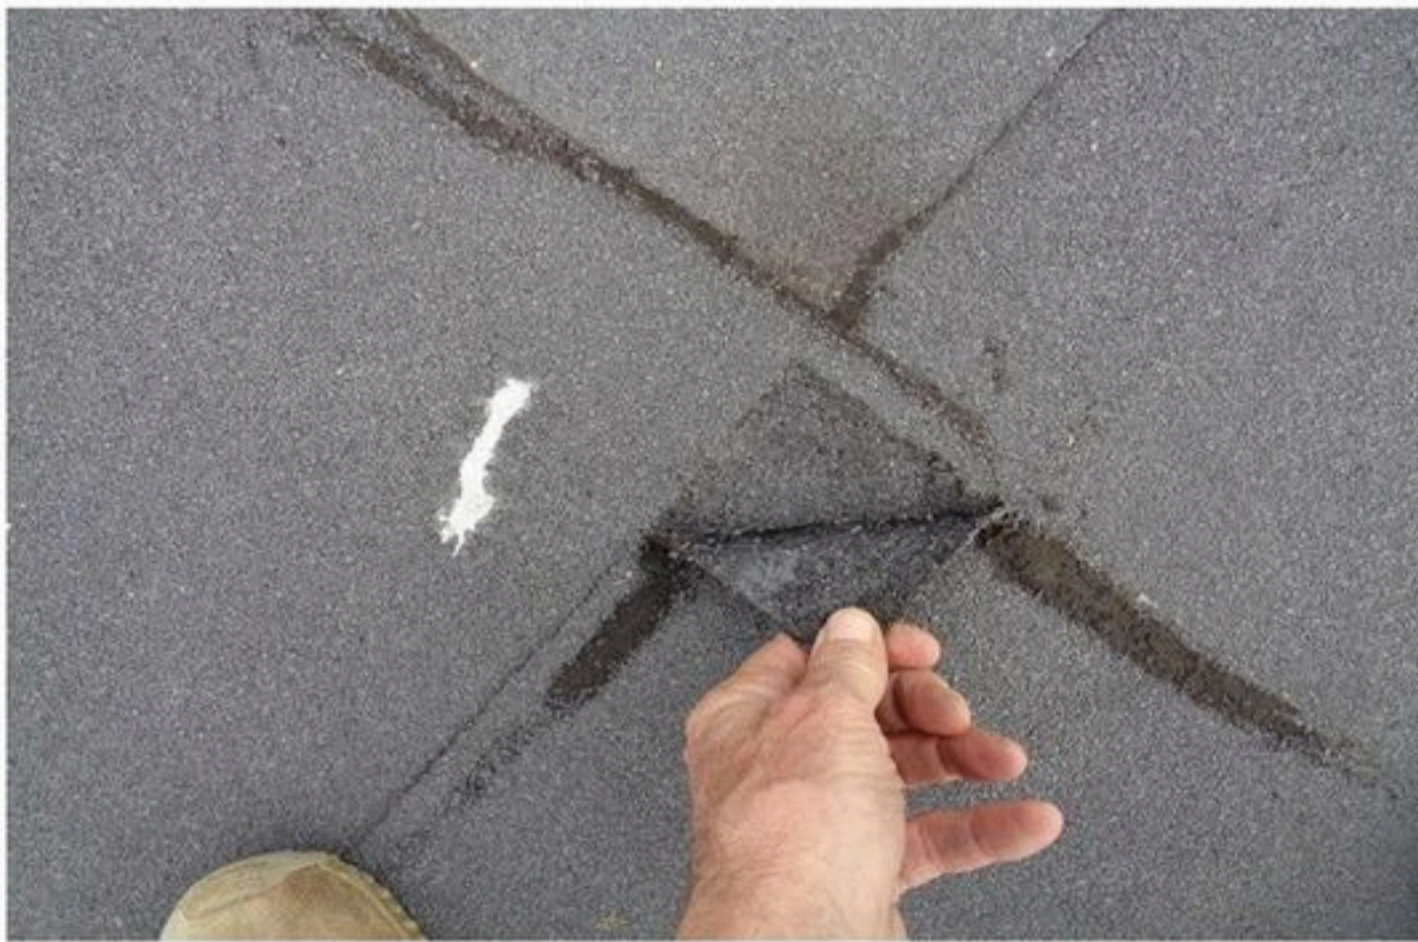
004

Images 004, 005 and 006

When a cap sheet membrane is torched to seal on top of another cap sheet membrane, the underlying granulated surface must have the granules embedded by heating and trowelling the underlying membrane on a strip 4" wide along the width of the seam.

This action was not performed.

This procedure is mandated in IKO and Soprema Canadas' installation guide and CRCA (Canadian Roofing Contractors Association) requirements.

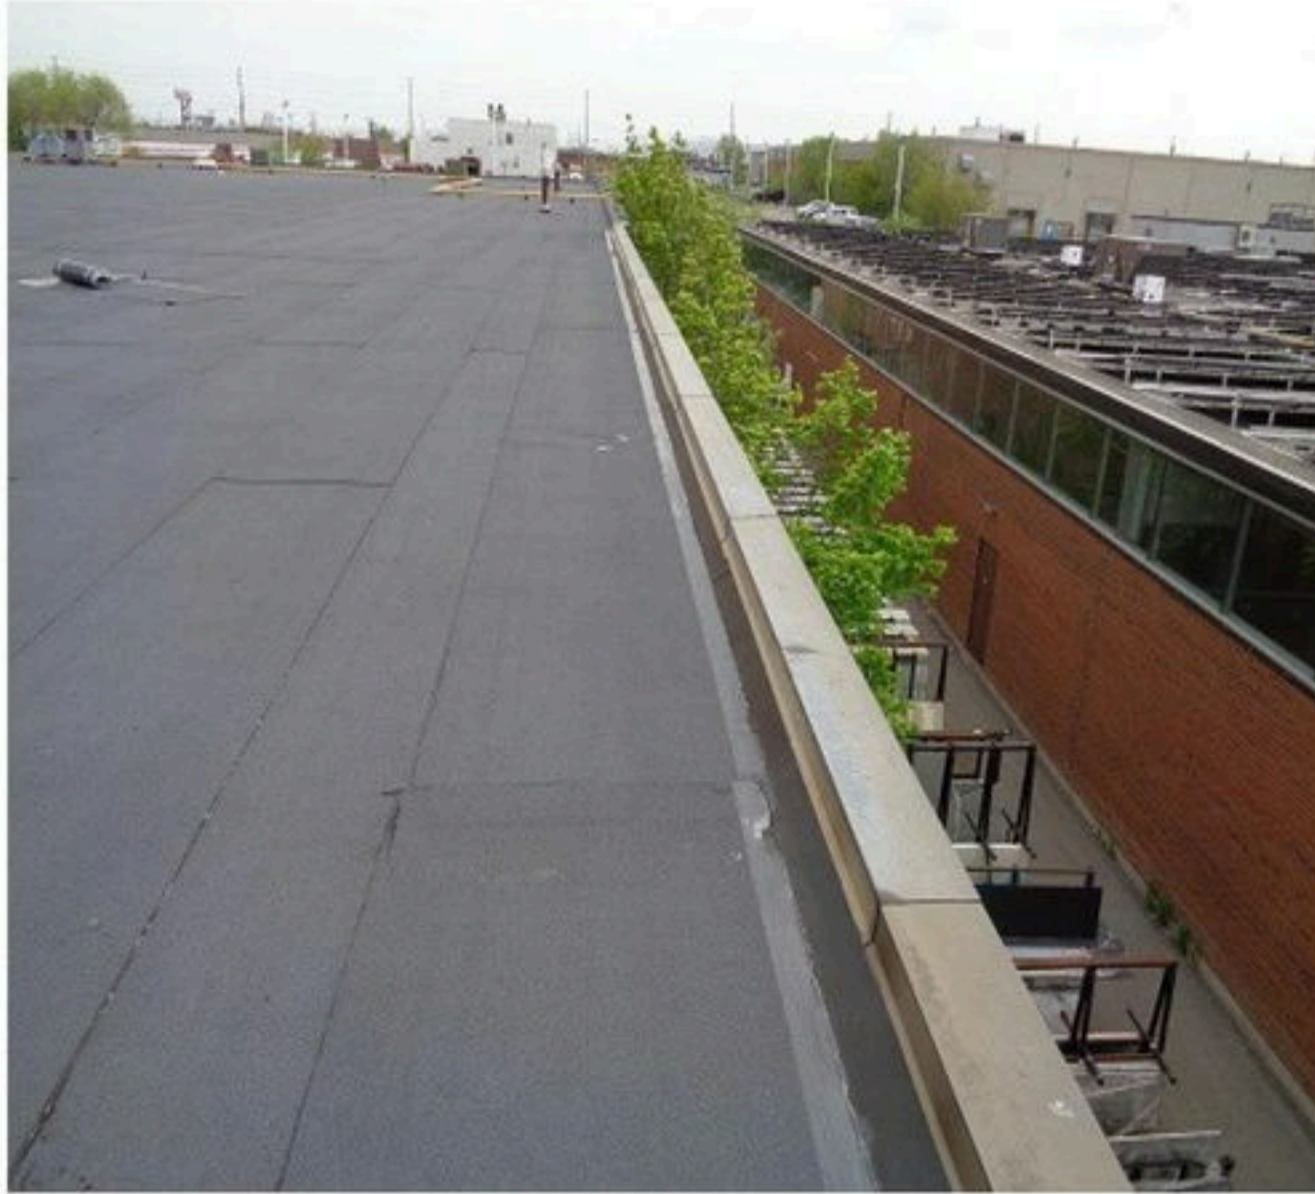
Images 007 and 008.

Perimeter membrane 'flashing' not complete.

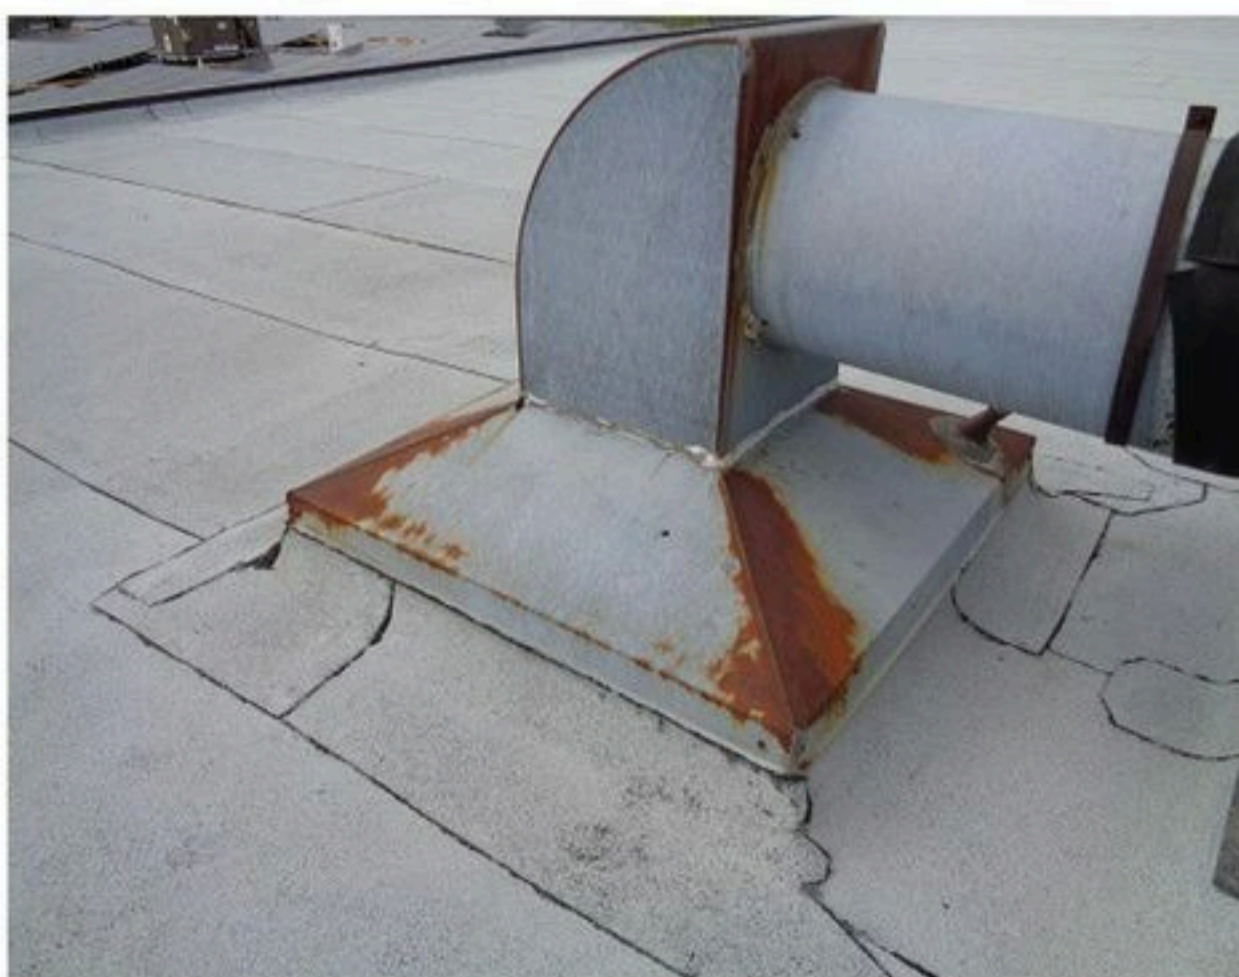
008

Image 008. Adjacent roofing showing that the unit has been lifted and the membrane set beneath

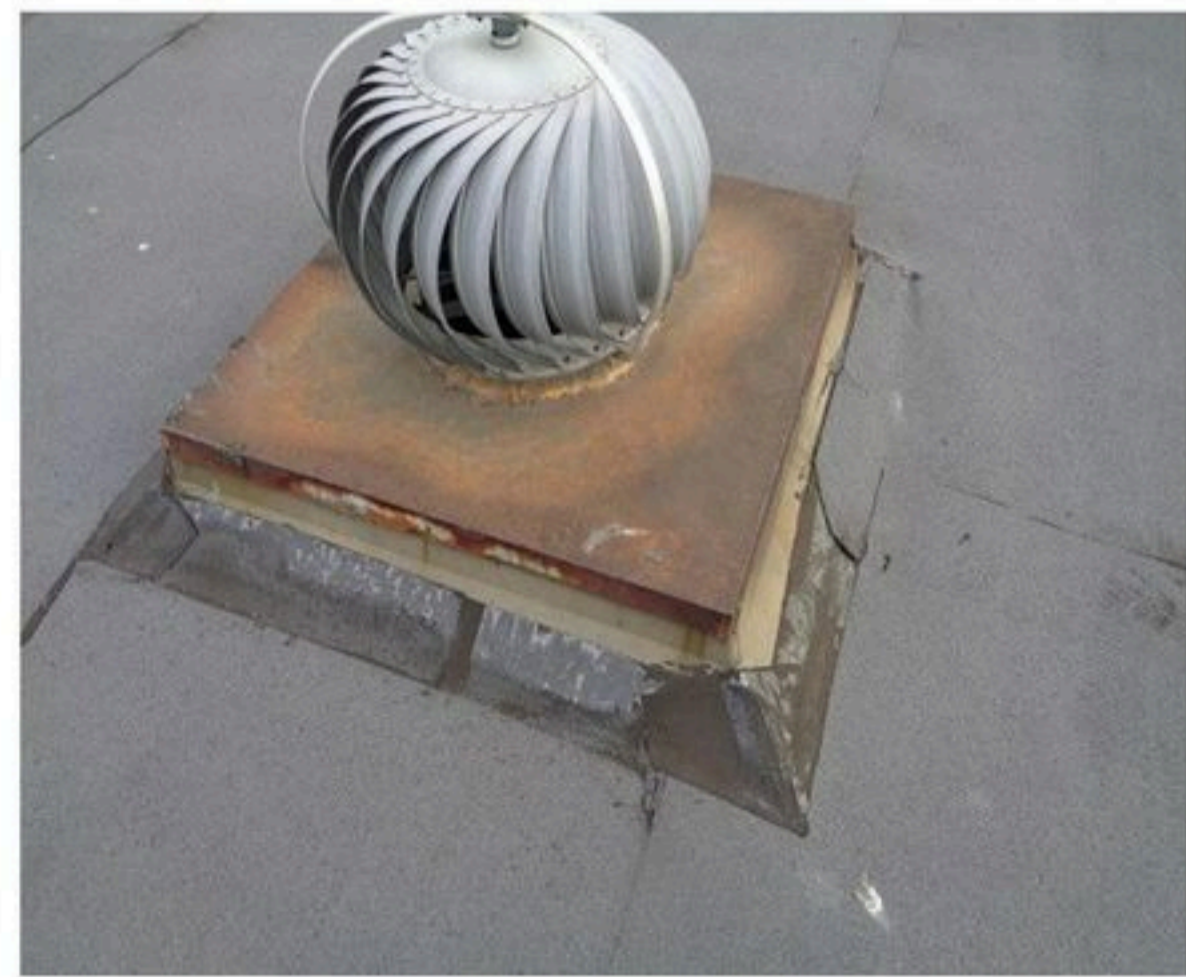
009

Image 009. Membrane adhered to metal work. All equipment set on a curb must be removed, the membrane set, up and over the curb, and the unit put back. This membrane termination will not survive.

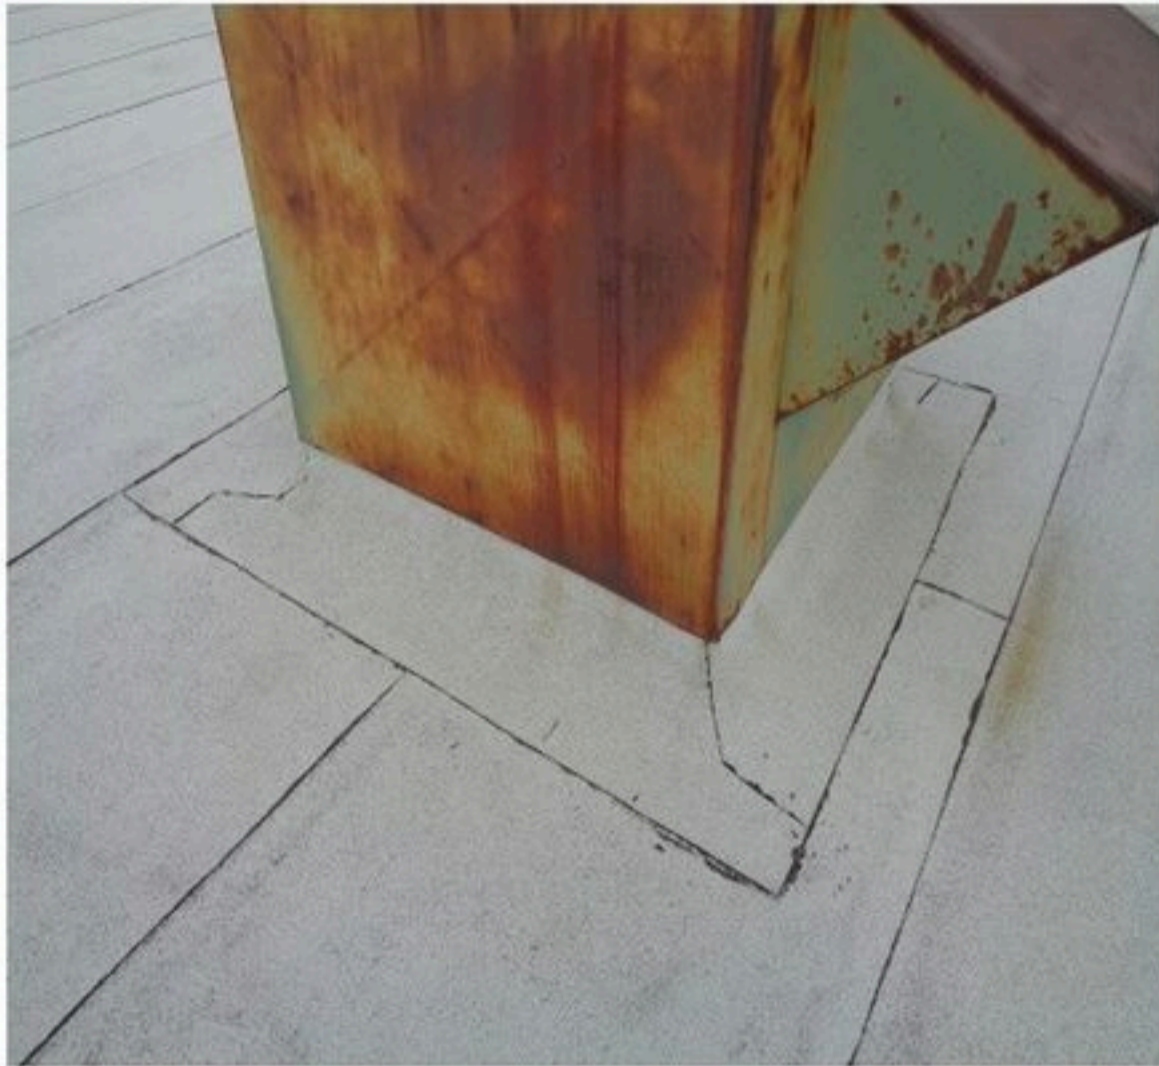
010

Image 010. Adjacent roof section. Membrane correctly set beneath the metal.

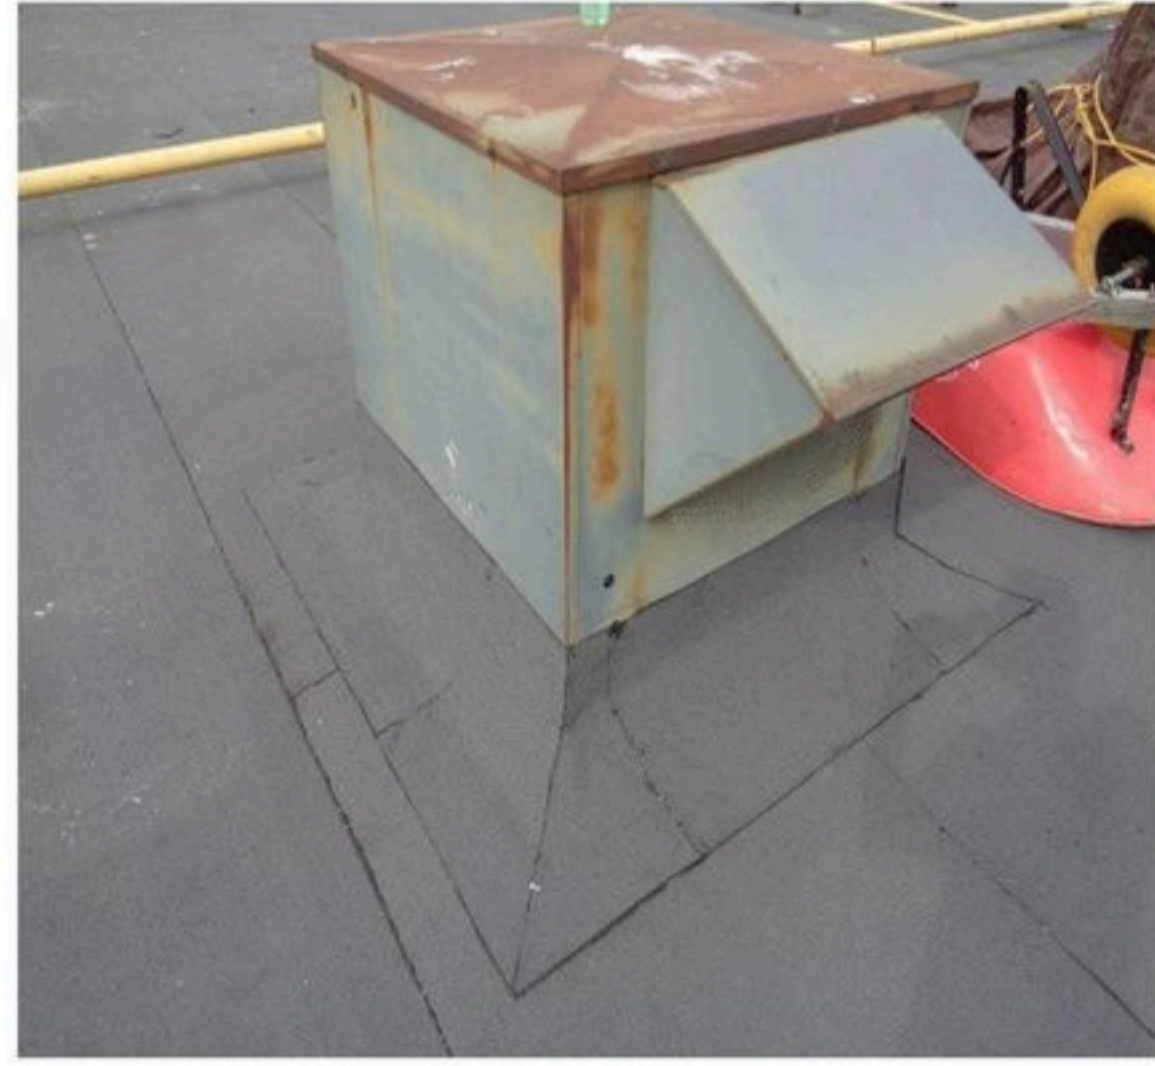
011

Image 011. 'New Roof'. Membrane stuck to the sheet metal of the unit. It will not survive.

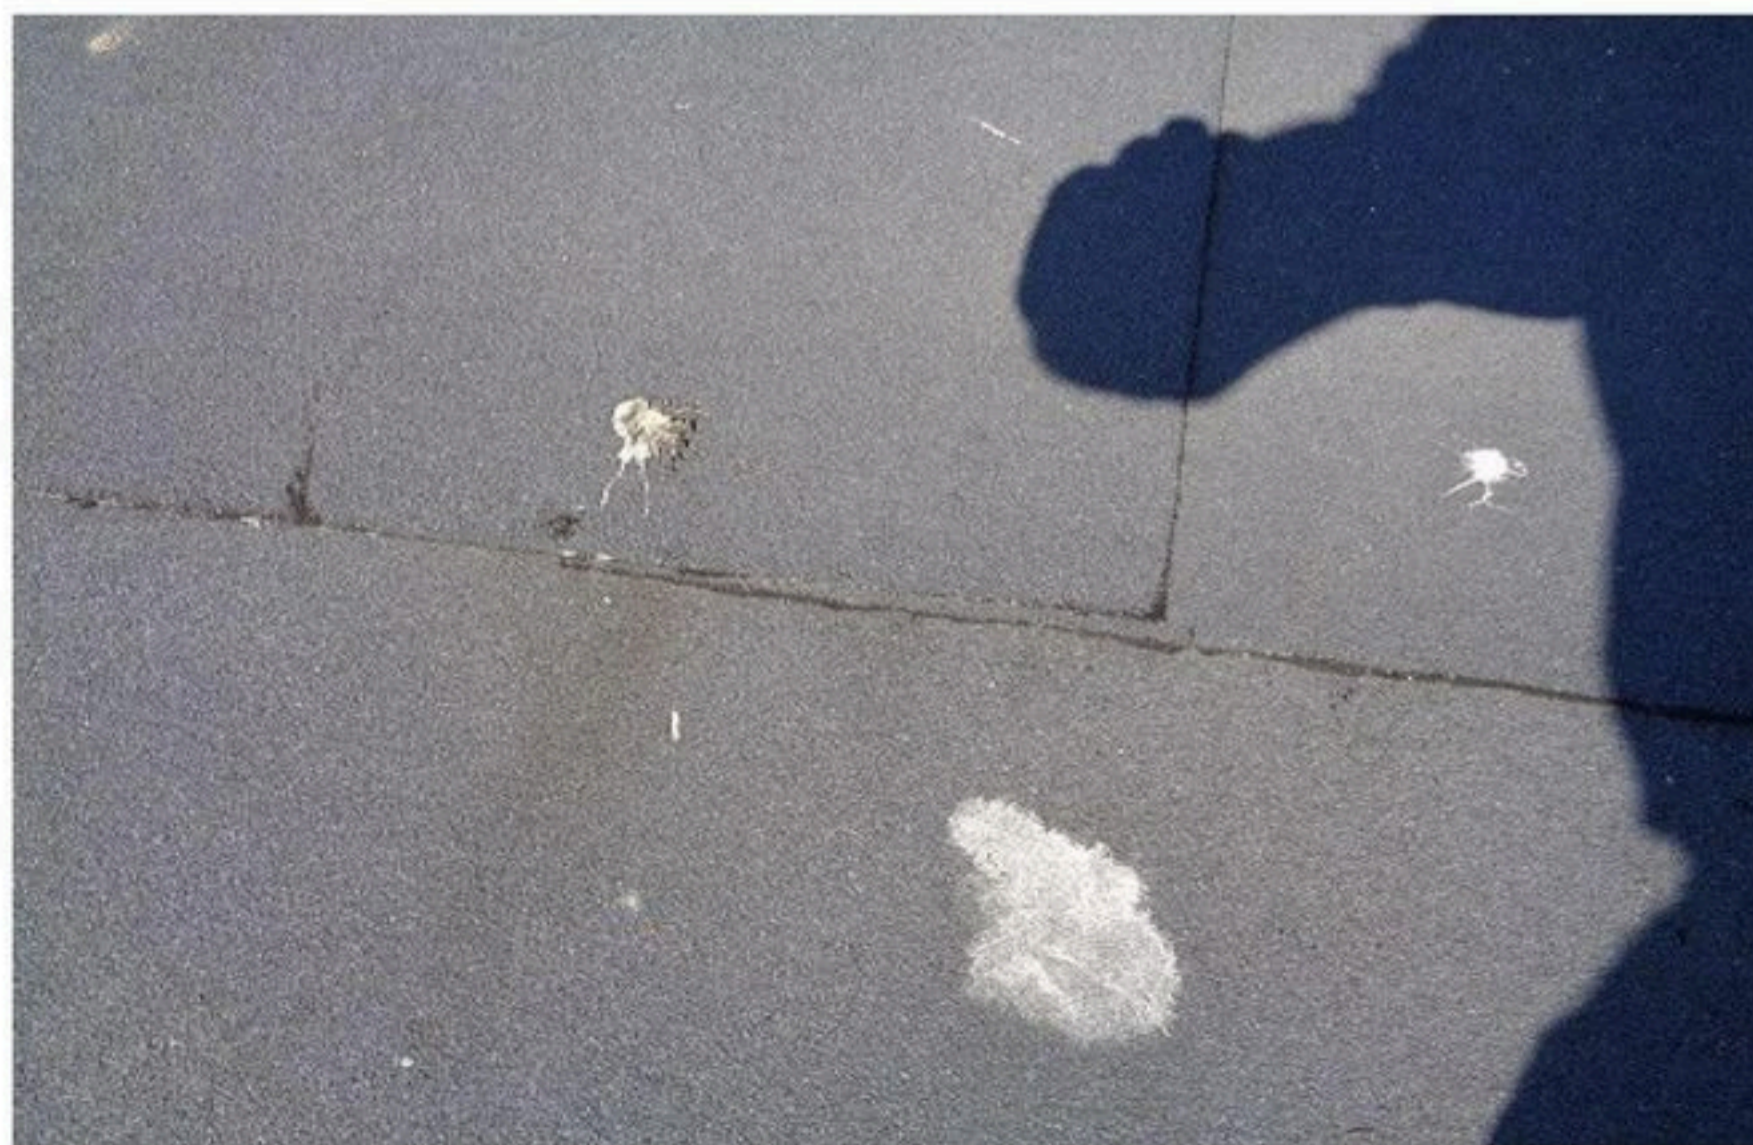
012

Image 012.

A 'T Lap' is created when the underlying membrane is trimmed at a 45 degree angle from the end of the overlying lap. This is a requirement of all membrane manufacturers and the CRCA Specifications Manual.
