INDEPENDENT ROOF INSPECTION SERVICES LTD.

INSPECTION REPORT

AUGUST 21 2022
OLYMPUS AVENUE.
TORONTO ONT.

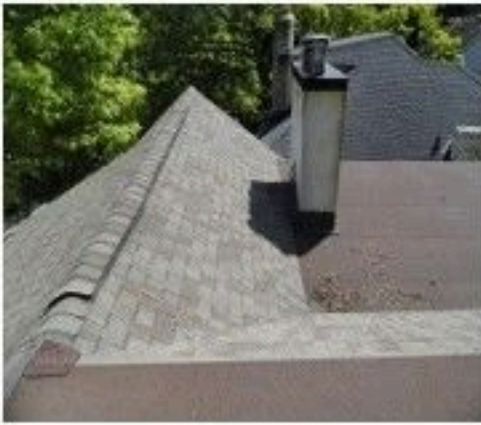
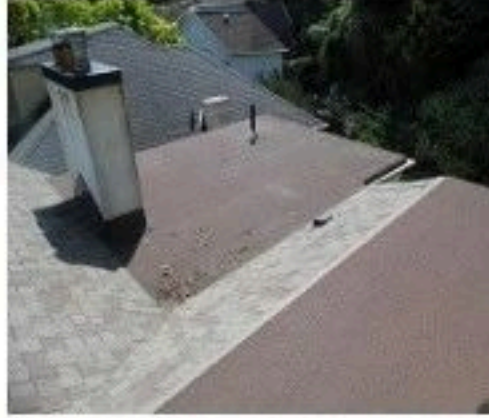
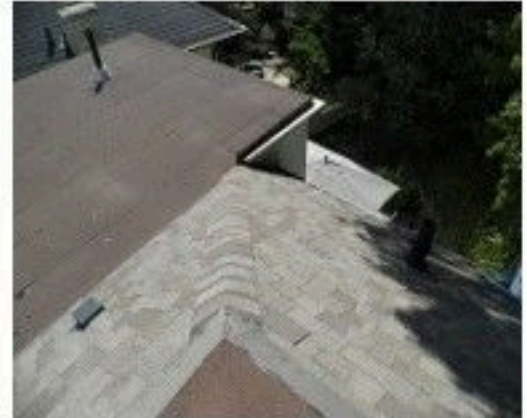
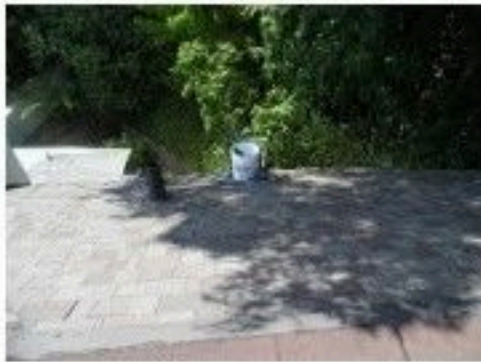
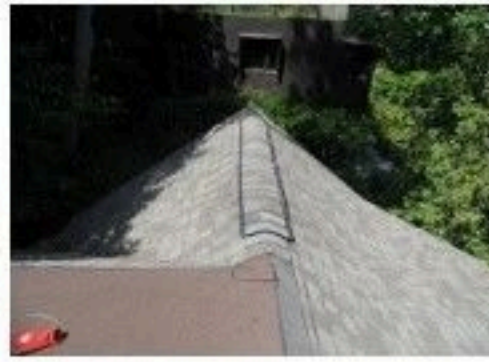
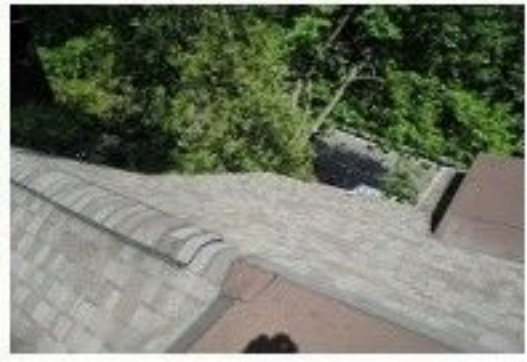
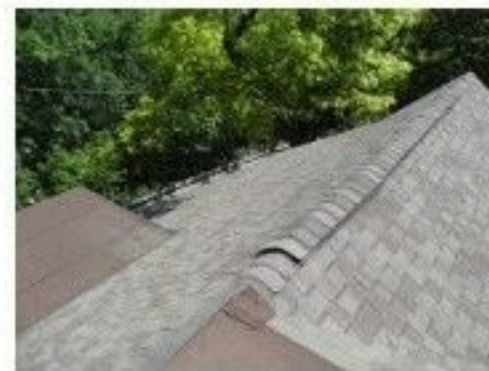
OVERVIEWS. SLOPED ROOFING.

We are pleased to report that except for the deficiencies listed herein, all shingle exposures, both upper and lower, exhibit the following.

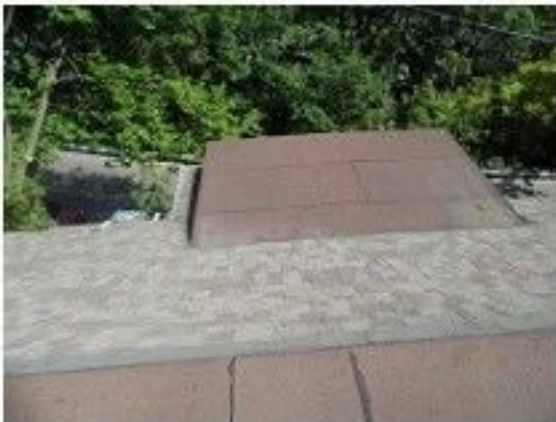
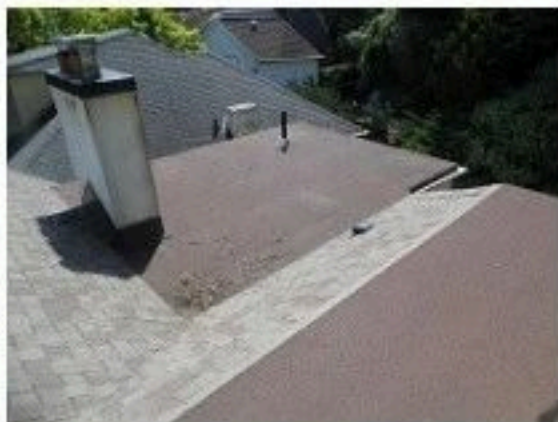
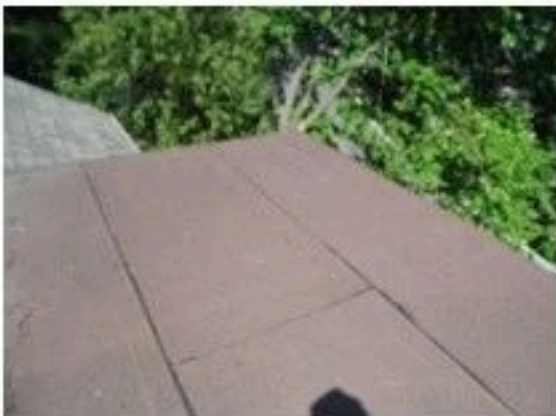
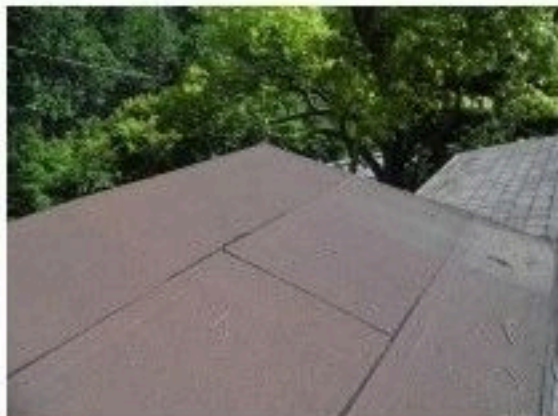
FLAT ROOFING OVERVIEWS.

We are pleased to report that the fields of all the flat roofs are sound and should remain serviceable for at least five years..

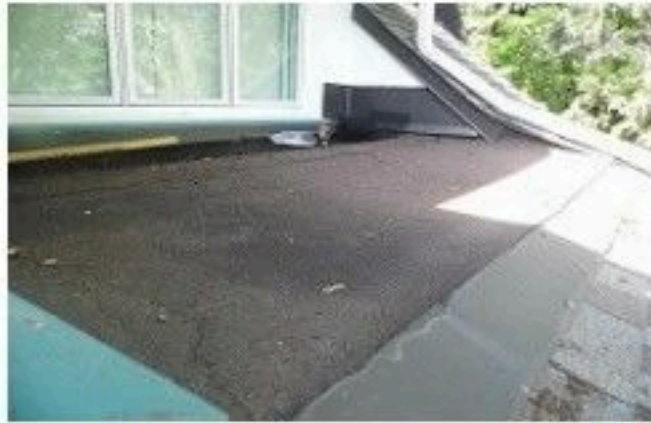
Front Lower flat.

Common to all heat welded flat roof membranes where the sheet metal drip edge was not properly primed. The membrane becomes loose.

All of the roof s and their perimeters show this deficiency.

- 1) Replace damaged ridge cap shingle.
- 2) Replace loose material.
